# Tram Extension, Edinburgh

Ocean Terminal to York Place  
Road Safety Audit Stage 3

The City of Edinburgh Council

Project number: 60651312  
AECOM Reference: RSA/316/S3-A

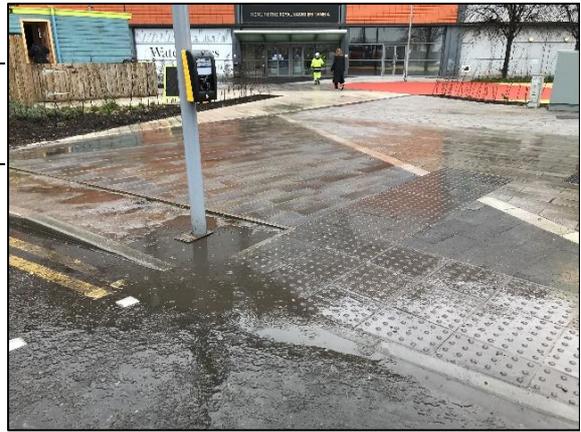
**Summary:** Excess surface water increases the risk of vehicles skidding, particularly during periods of cold / freezing weather

During the site investigation, areas of standing water were observed on the carriageway. Excess surface water increases the risk of vehicles skidding, resulting in loss-of-control collisions and personal injury. This is particularly pertinent during periods of cold / freezing weather when standing water could form ice.

It is recommended that drainage is appropriate throughout the scheme extents.

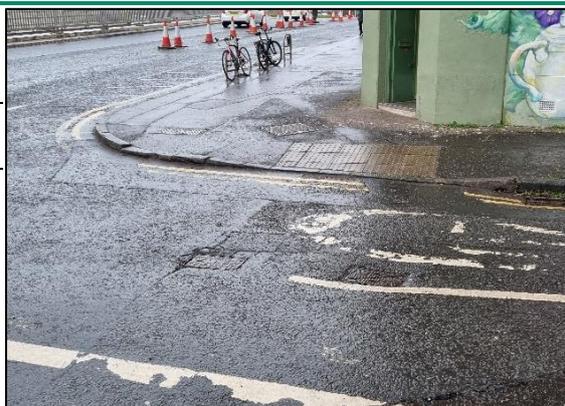
**Summary:** Risk of crossing pedestrians being struck by vehicles.

On Hawthornvale at its junction with Lindsay Road, several issues were noted with the uncontrolled crossing layout:

The following measures are recommended:

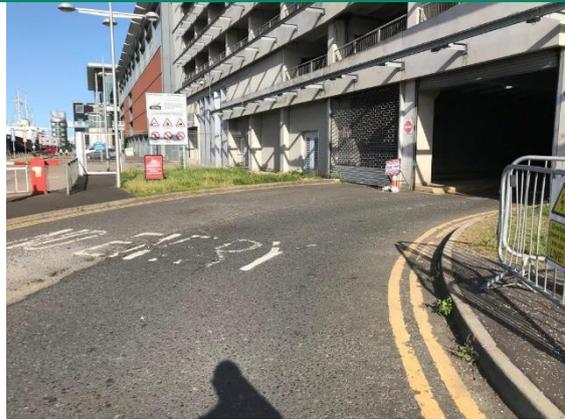
**Summary:** Risk of side swipe collisions between motorised vehicles exiting the car park, sustaining personal injuries.

During the site investigation it was observed that at the car park exit to Ocean Terminal two lanes exit from the car park, however, they merge into a single lane at the junction to Melrose Drive. There is a risk of side swipe collisions between motorised vehicles exiting the car park, sustaining personal injuries.

It is recommended that the exit to the car park be reduced to a single lane.

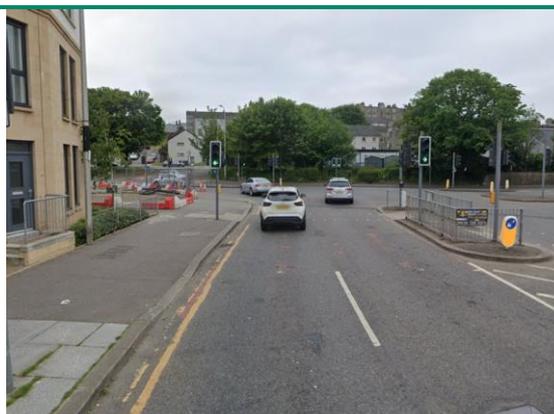
**Summary:** Risk of vehicles crossing the stop line when it is not safe to do so and striking and injuring crossing pedestrians or striking passing vehicles, due to stop lines on Sandpiper Drive southbound not being visible.

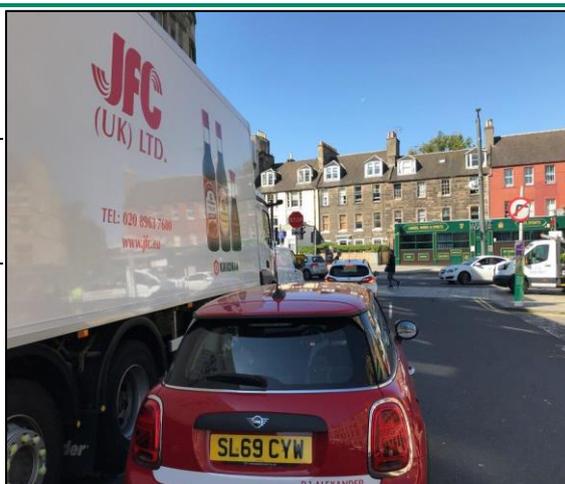
Secondary risk of rear-end shunts due to vehicles waiting for extended periods on Leith Walk whilst waiting for non-motorised users to cross the side road.

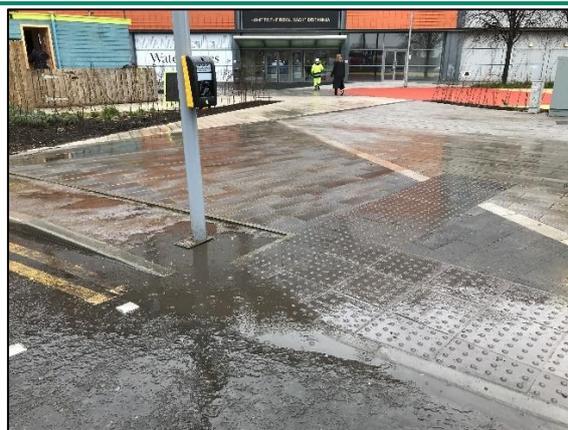
Excess surface water on the footway could lead to pedestrians slipping and falling, resulting in them sustaining personal injuries.

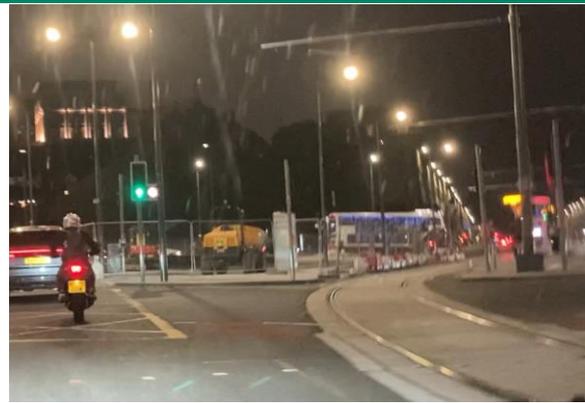
**Summary:** Risk of conflict between south-westbound general traffic and a tram, pedestrian, or other vehicles as a result of entering the Tram only lane.

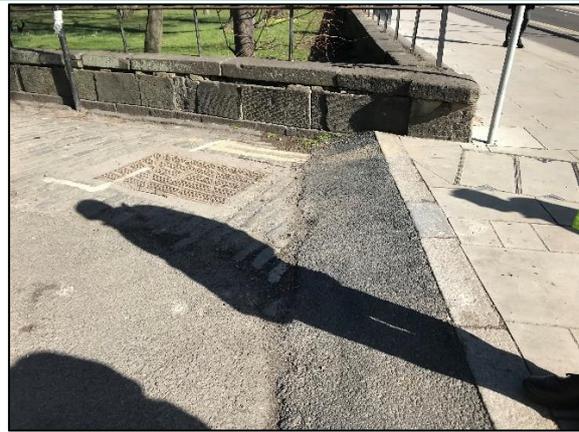
**Summary:** Risk of vehicles losing control on ramps due to gradient, resulting in potential collision with other road users or riders of powered two wheelers becoming unseated and falling from their bikes.

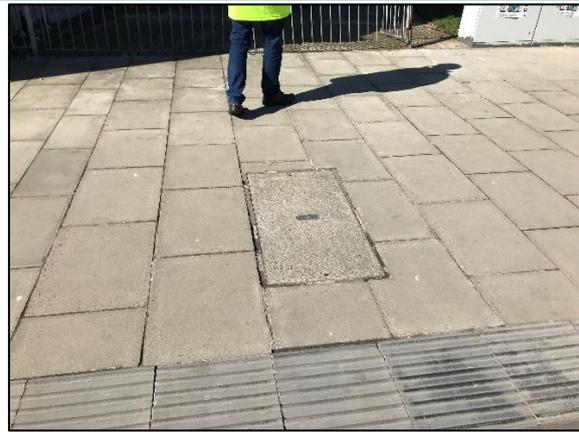
**Summary:** Risk of utility cover failing as a result of vehicle loading, leading to a void forming that pedestrians could trip on and sustain personal injuries.

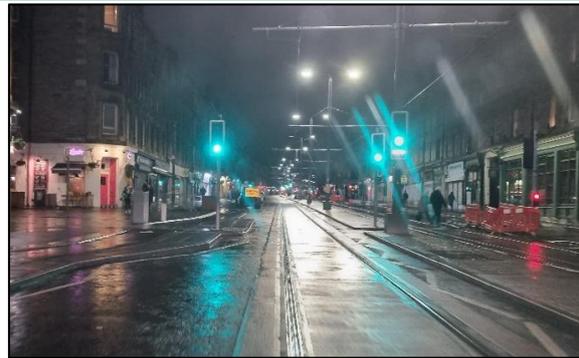
**Summary:** Risk of vehicles striking kerb lines due to inconsistent alignment, leading to vehicle occupants sustaining personal injuries.

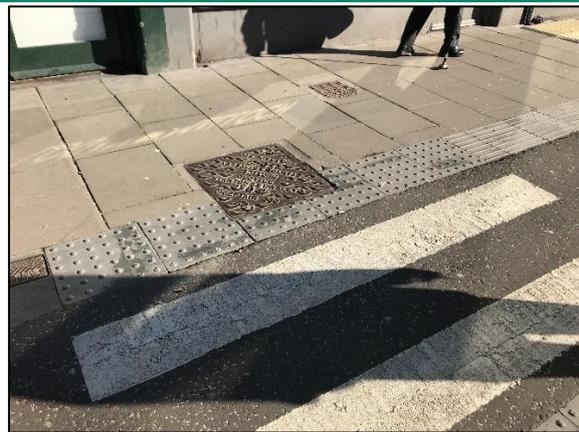
**Summary:** Risk of visually impaired pedestrians being unable to locate crossing points due to chamber covers being positioned within tactile paving, leading to them attempting to cross at unsafe locations and being struck and injured by passing vehicles whilst doing so.

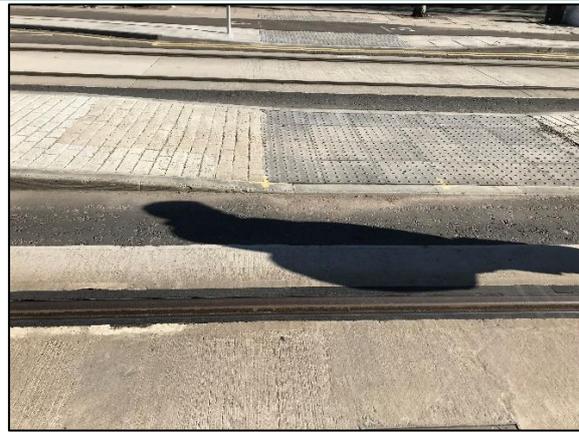
**Summary:** Risk of pedestrians tripping on kerb and sustaining personal injuries due to tactile paving being positioned on a transition kerb.

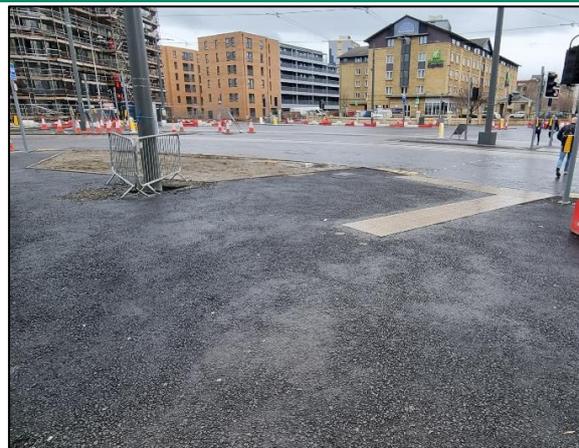
**Summary:** Risk of visually impaired pedestrians being unable to locate controlled crossing point, leading to them attempting to cross at unsafe locations and being struck and injured by passing vehicles whilst doing so.

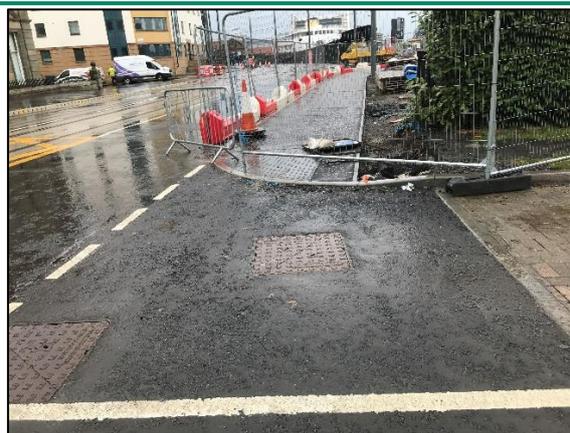
**Summary:** Risk of visually impaired pedestrians inadvertently stepping onto the carriageway due to footway being flush with carriageway, leading to them being struck and injured by passing vehicles.

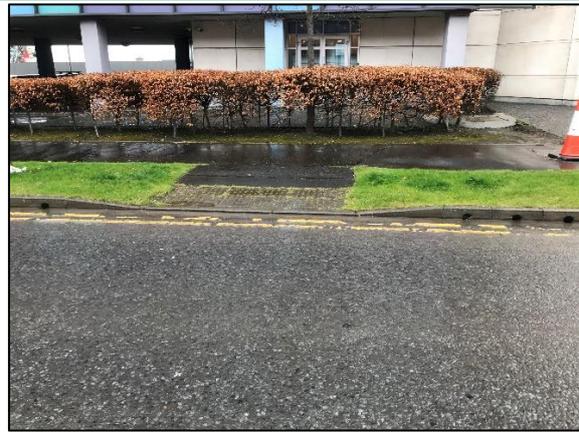
**Summary:** Risk of pedestrians tripping on kerb upstands and sustaining personal injuries.

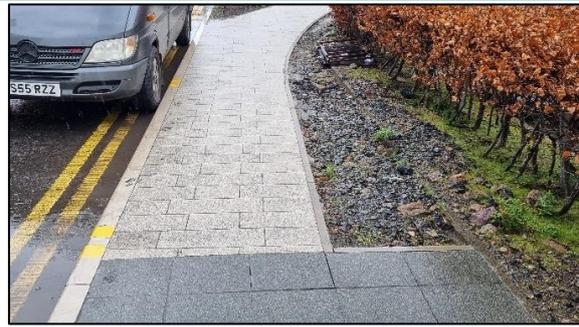
**Summary:** Risk of pedestrians stepping onto carriageway and being struck and injured by passing vehicles due to narrow footway width.

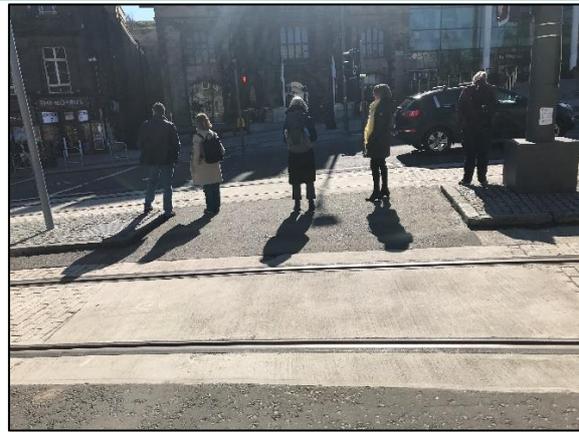
**Summary:** Risk of pedestrians being struck and injured by vehicles whilst crossing due to inadequate green man times and long crossing lengths.

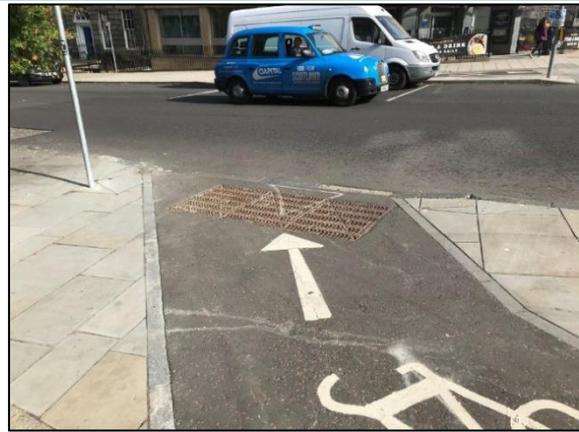
**Summary:** Risk of cyclists failing to give way and emerging into the path of vehicles, resulting in them being struck and injured, due to absence of give way markings.

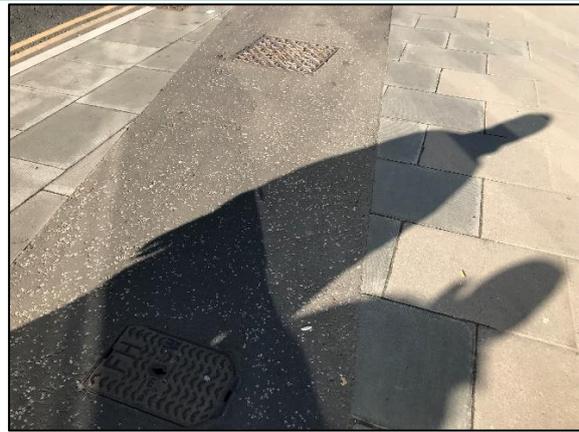
**Summary:** Risk of visually impaired pedestrians inadvertently entering cycleway and being struck and injured by cyclists due to minimal segregation being provided.

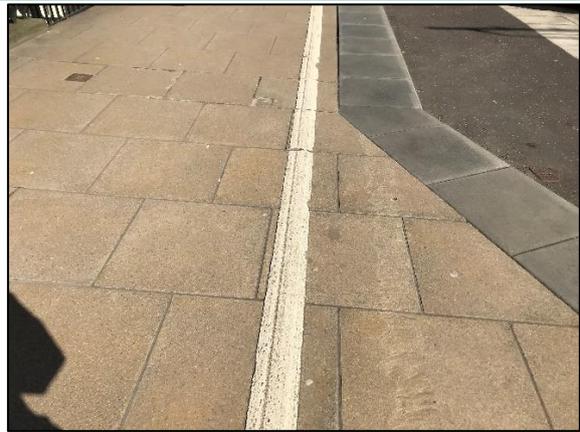
**Summary:** Risk of pedestrians tripping and falling on segregation associated with previous arrangement, resulting in them sustaining personal injuries.

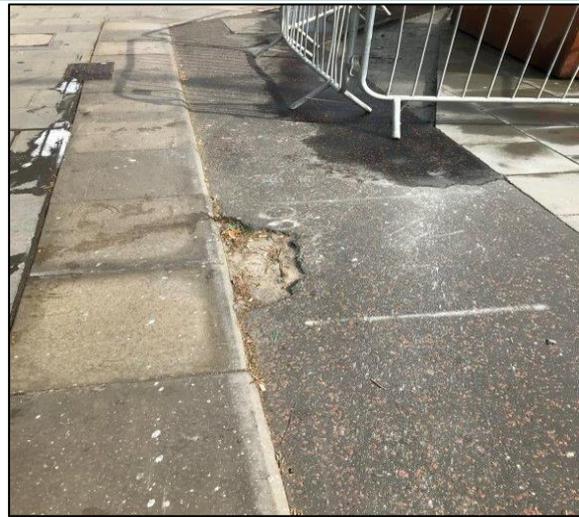
Secondary risk of cyclists taking evasive action to avoid uneven surface, resulting in them losing control or striking and injuring pedestrians.

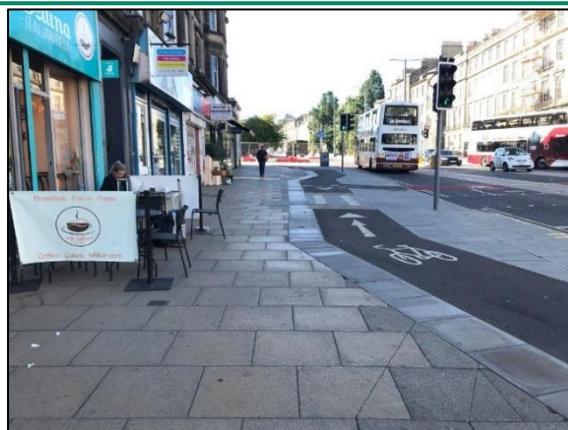
**Summary:** Risk of pedestrians stepping onto the cycleway to pass encumbered pedestrians or users using mobility aids due to restricted footway width, resulting in them being struck and injured by cyclists.

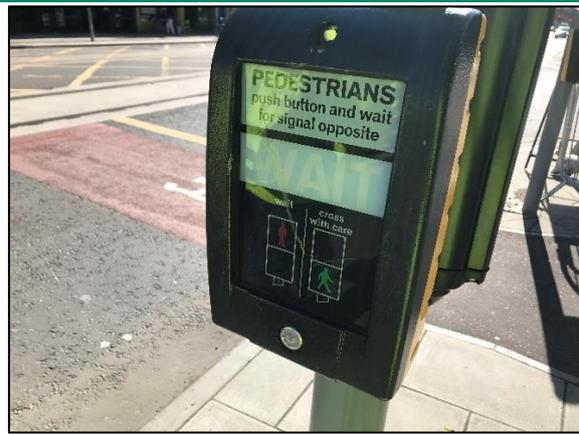
**Summary:** Risk of pedestrians crossing when not safe to do so due to pushbuttons not functioning, resulting in them being struck and injured by passing vehicles.

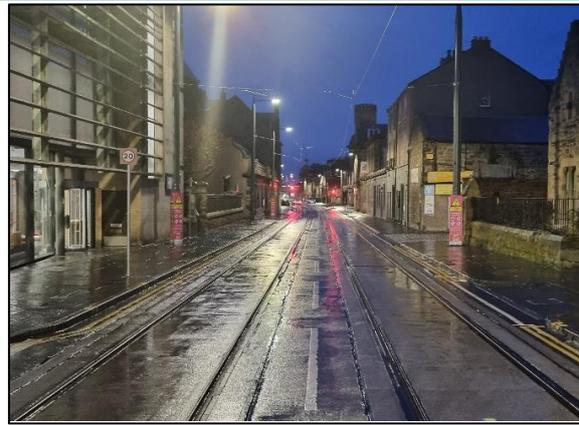
**Summary:** Risk of vehicles entering the tram track area and colliding with trams or failing to follow road markings resulting in confusion and late lane changes or manoeuvres, due to the conspicuity of road markings laid on concrete.

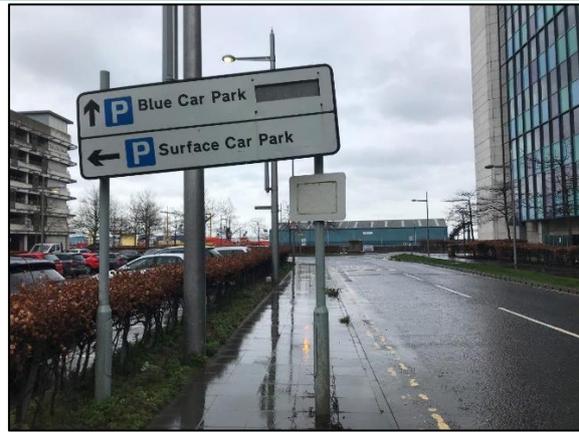
**Summary:** Risk of pedestrians striking signs mounted at inappropriate heights, resulting in personal injuries.

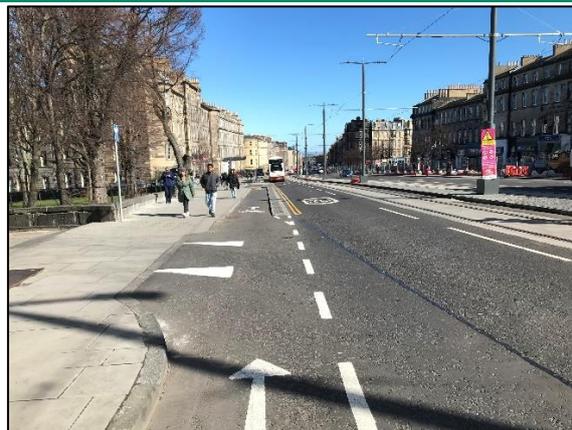
**Summary:** Risk of vehicles striking islands or segregation strips, resulting in vehicle occupants / riders sustaining personal injuries, due to absence of vertical features to highlight islands / segregation strips.

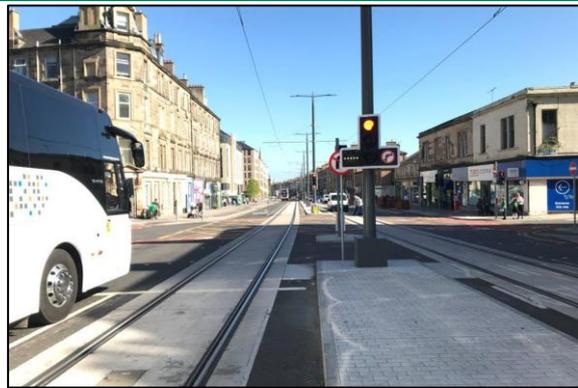
**Summary:** Risk of vehicles undertaking unsafe manoeuvres, and striking other vehicles whilst doing so, due to signage being obscured by signal heads.

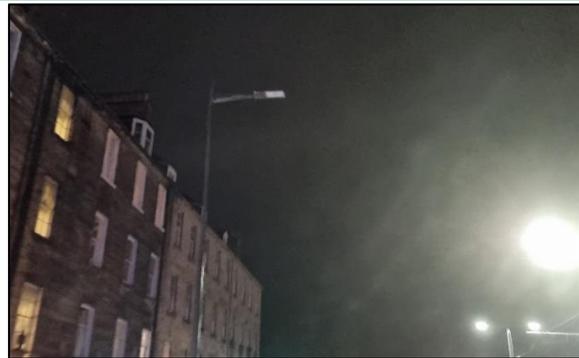
**Summary:** Risk of vehicles colliding with other vehicles, street furniture, or crossing non-motorised users, due to inadequate illumination.

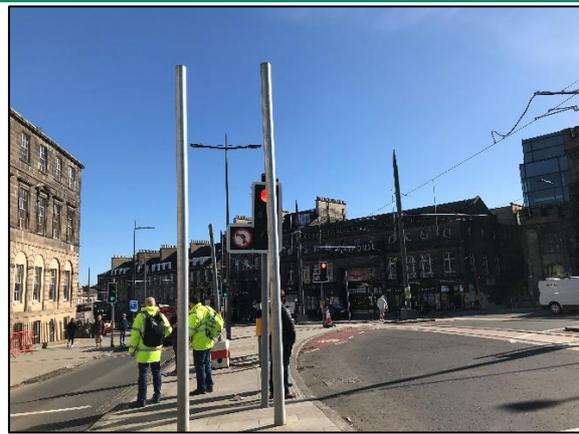
**Summary:** Risk of vehicles proceeding through red light due to primary signal head being obscured by sign face, resulting in vehicles striking trams or other vehicles.

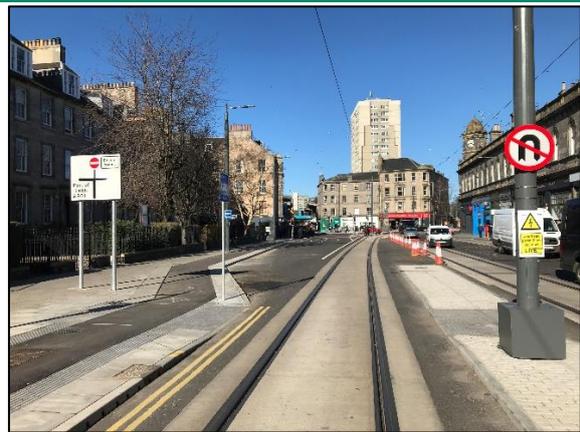
**Summary:** Risk of general traffic entering tram only lanes, resulting in conflict with trams or vehicles making sudden lane changes and colliding with other vehicles.

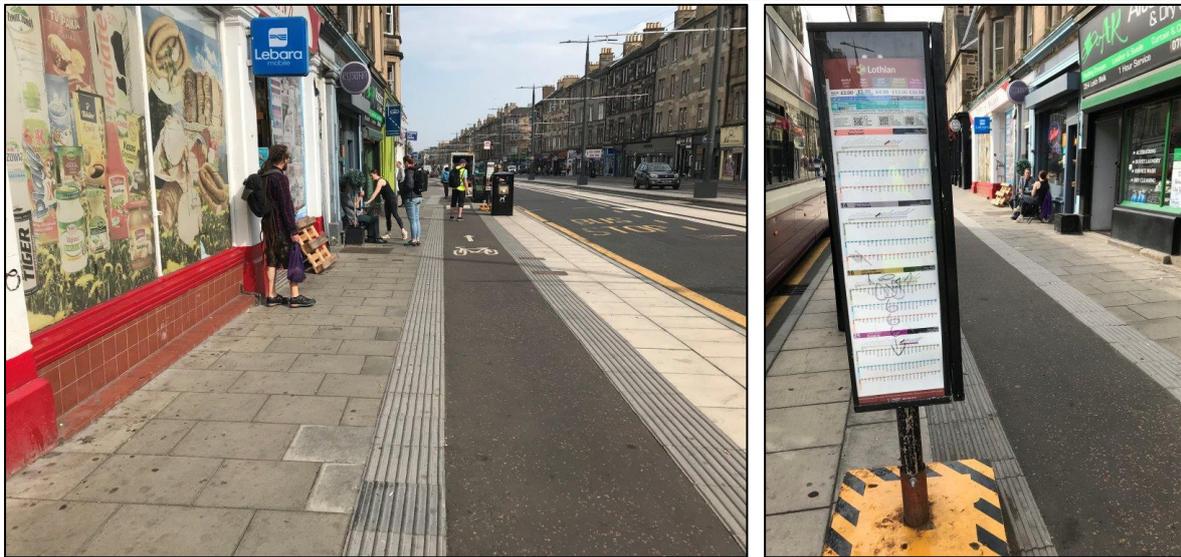
**Summary:** Risk of cyclists striking and injuring pedestrians due to intervisibility being obscured by bus stop flag and litter bin.

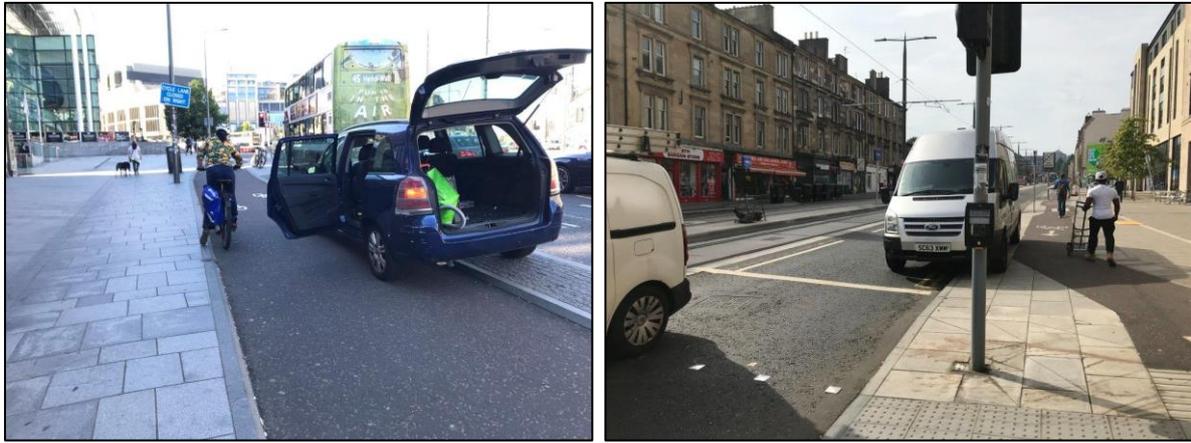
**Summary:** Risk of vehicles striking and injuring cyclists or crossing pedestrians due to indiscriminate loading on Leith Walk.

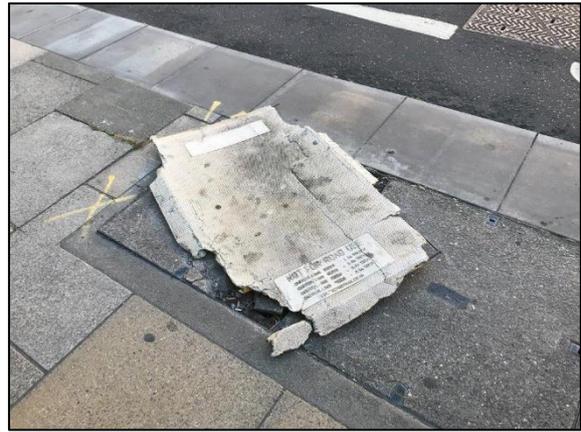
**Summary:** Risk of pedestrians tripping and falling on damaged chamber cover or plastic cover, resulting in them sustaining personal injuries.

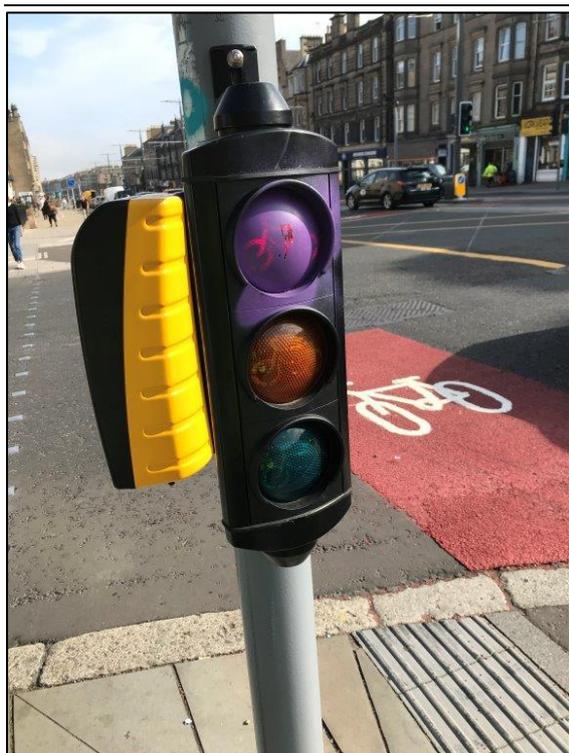
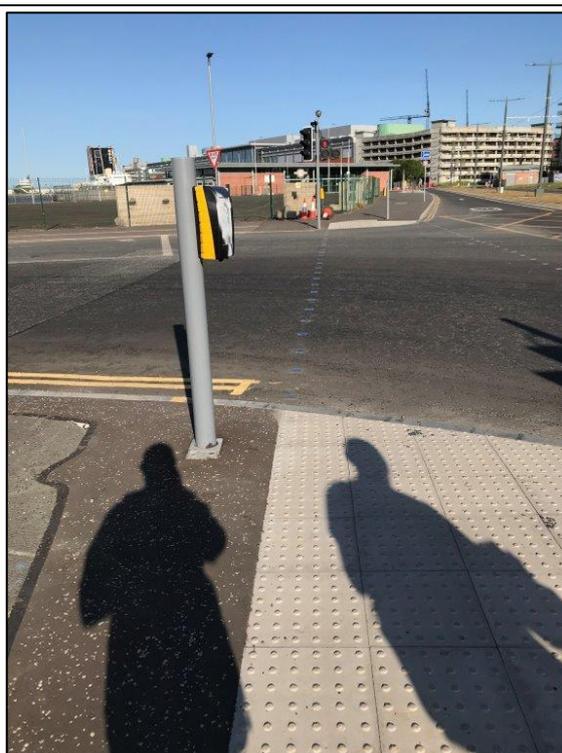
**Summary:** Risk of non-motorised users crossing when not safe to do so due to pedestrian units / low level cycle signals being obscured by vandalism, resulting in them being struck and injured by passing vehicles.

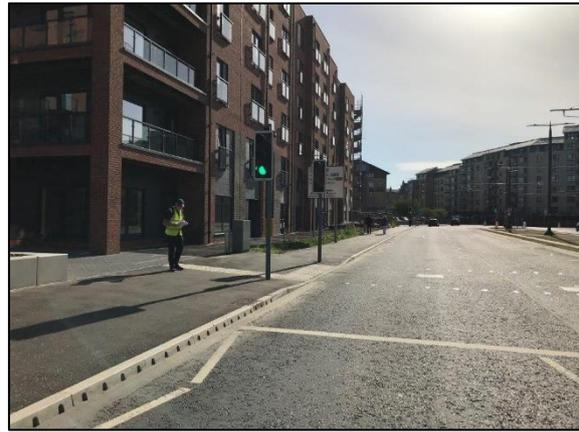
**Summary:** Risk of vehicles proceeding across the stop line when not safe to do so and striking and injuring crossing pedestrians, due to secondary signal head not functioning.

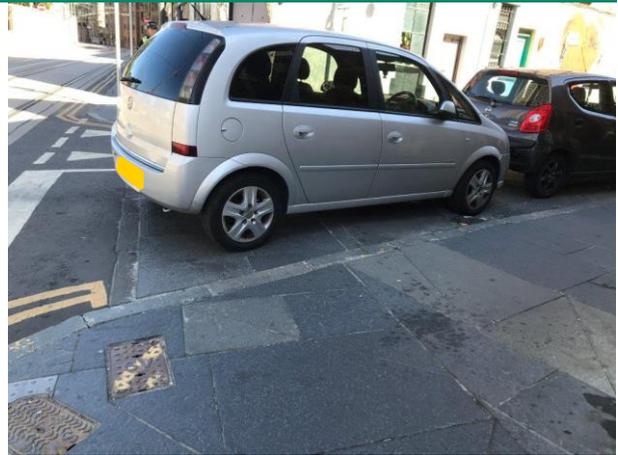
**Summary:** Risk of collisions between vehicles emerging from Laurie Street and crossing pedestrians or passing trams due to vehicles parking at junction with Constitution Street.

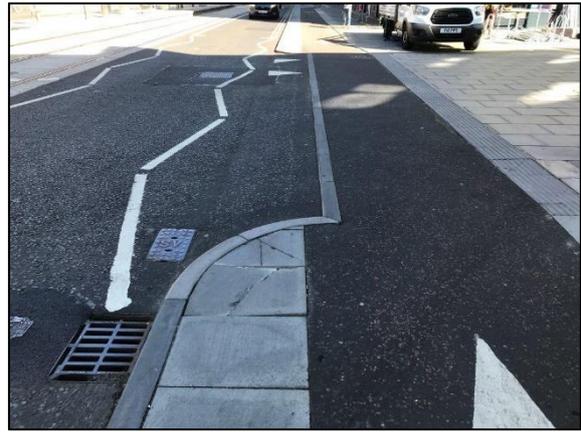
**Summary:** Risk of vehicles losing control when turning due to overrunning kerb line, resulting in vehicle occupants / riders sustaining personal injuries.

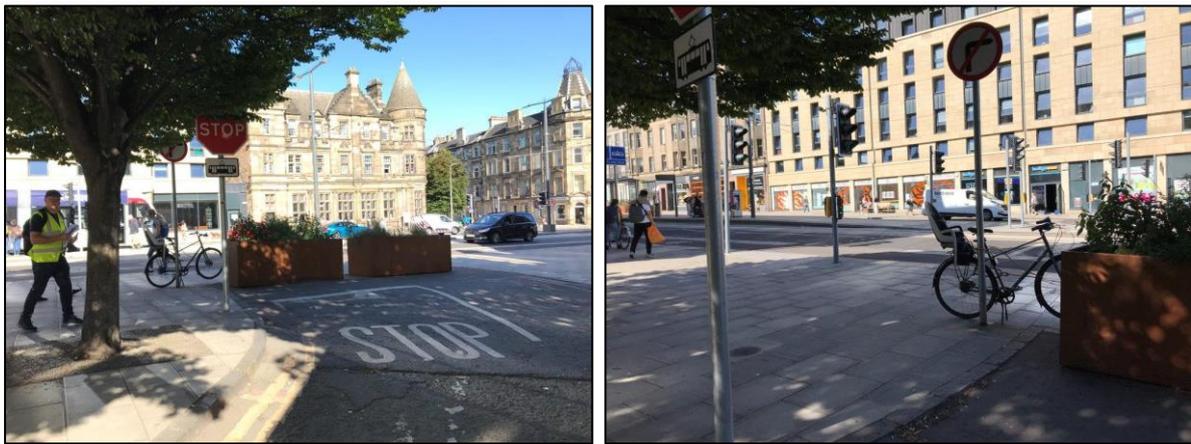
Secondary risk of vehicles undertaking unsafe manoeuvres upon finding there to be no access onto Leith Walk, resulting in them colliding with other road users or street furniture.

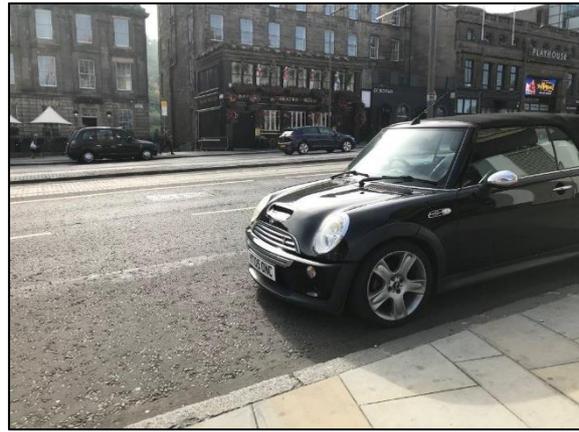
**Summary:** Risk of vehicles striking and injuring crossing pedestrians or cyclists due to intervisibility being obscured by parked vehicles.

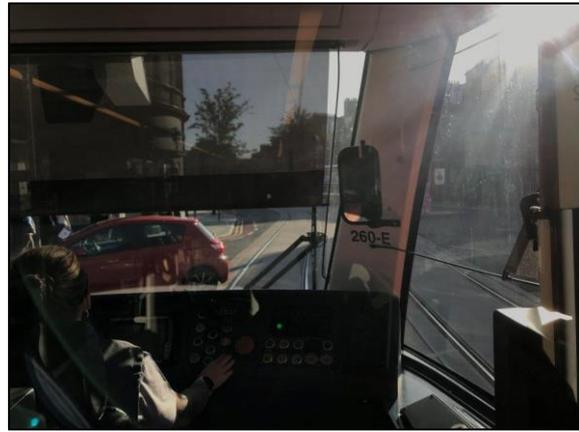
**Summary:** Risk of vehicles being struck by trams due to queuing across tram lines.

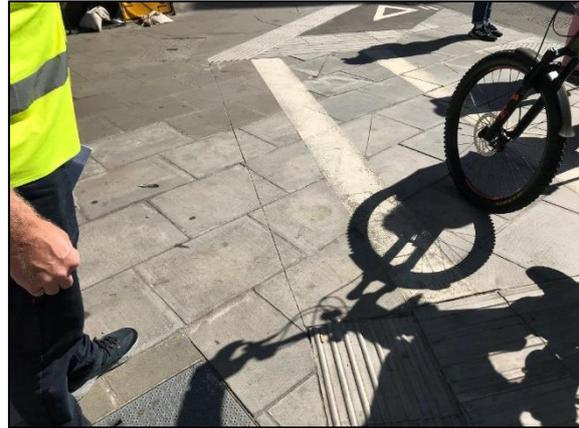
**Summary:** Risk of visually impaired pedestrians being unable to locate crossing due to confusing tactile paving layout, resulting in them crossing at unsafe locations and being struck and injured whilst doing so.

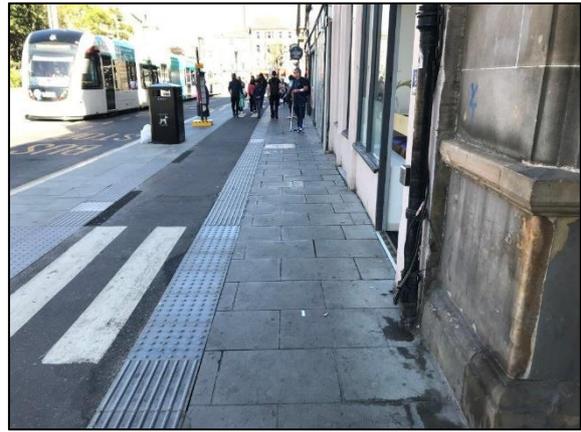
**Summary:** Risk of visually impaired pedestrians being unable to locate crossing points to floating bus stop, leading to them crossing at unsafe locations and being struck and injured by cyclists.

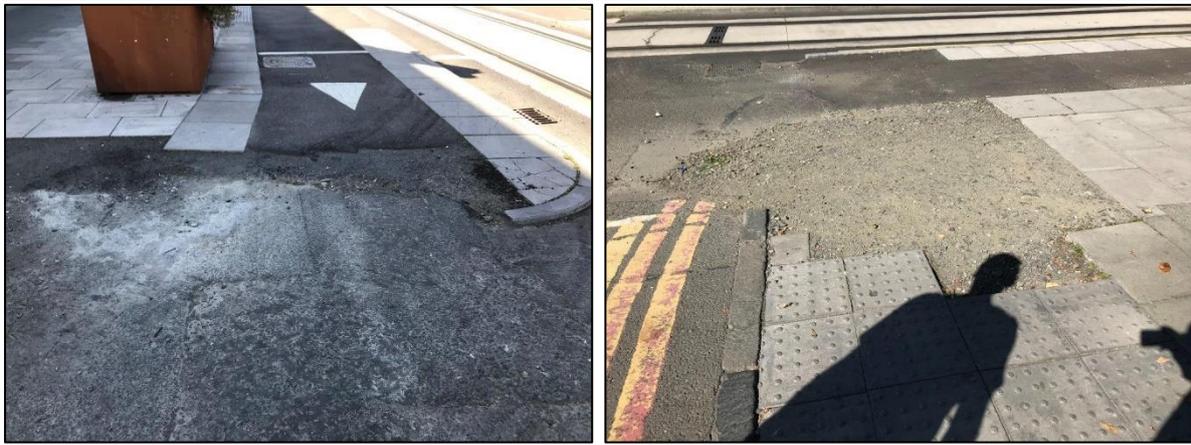
**Summary:** Risk of pedestrians tripping or cyclists losing control, due to carriageway / footway surfacing.

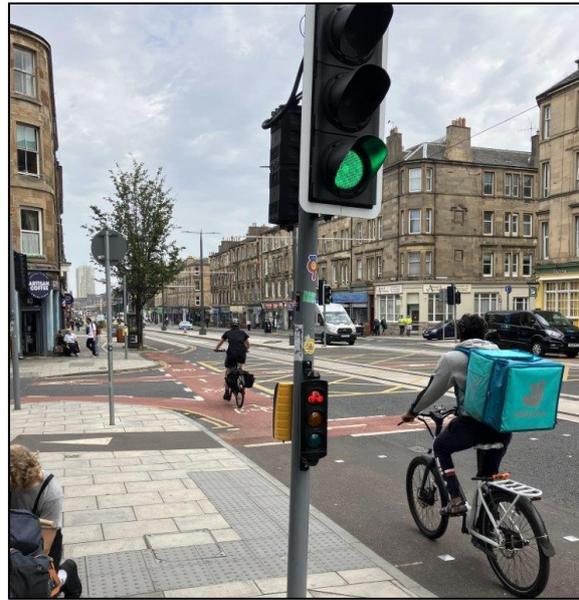
**Summary:** Risk of cyclists proceeding across stop line when vehicle aspect is on green and being struck and injured by left turning vehicles.

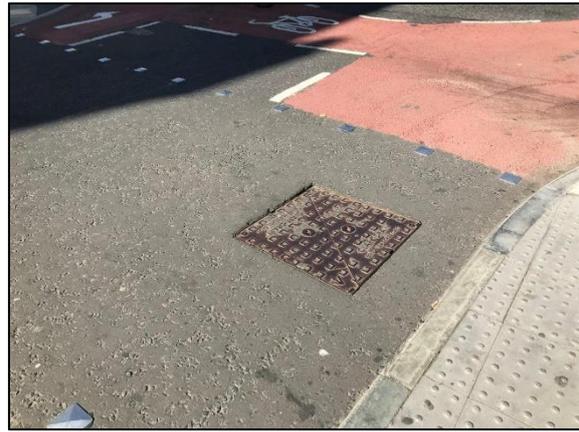
**Summary:** Risk of pedestrians slipping on chamber cover resulting in them falling and sustaining personal injuries.

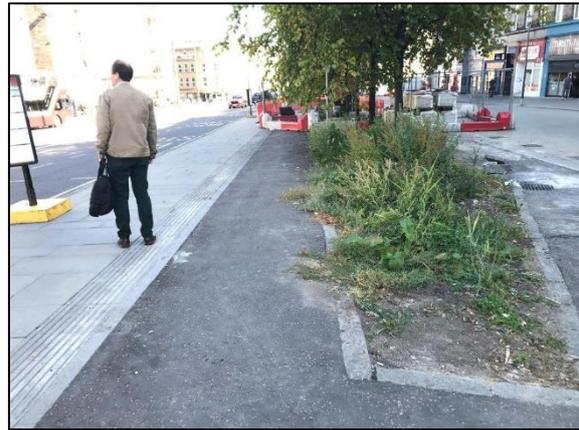
Secondary risk of cyclists encroaching onto footways to avoid overhanging vegetation and striking and injuring pedestrians whilst doing so.

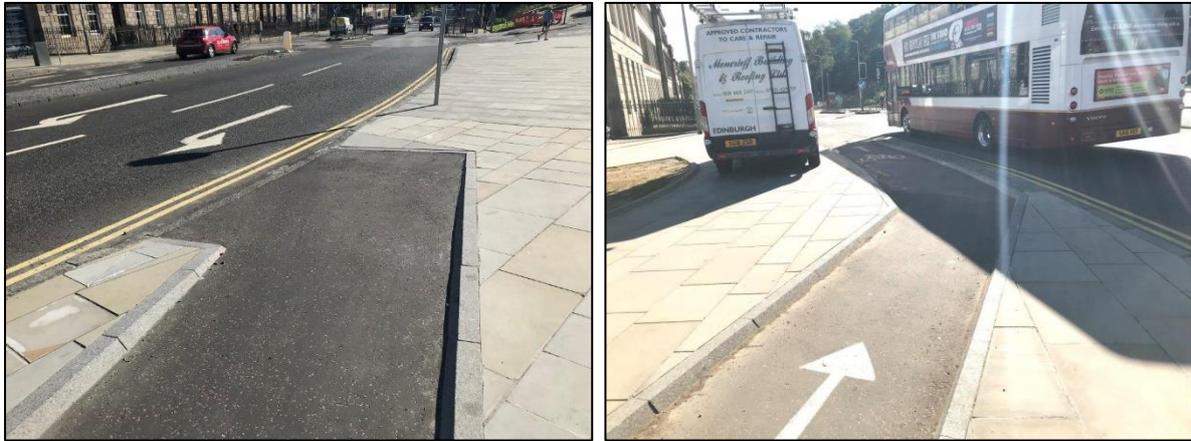
**Summary:** Risk of cyclists losing control when undertaking sharp turning manoeuvres, resulting in them falling and sustaining personal injuries.

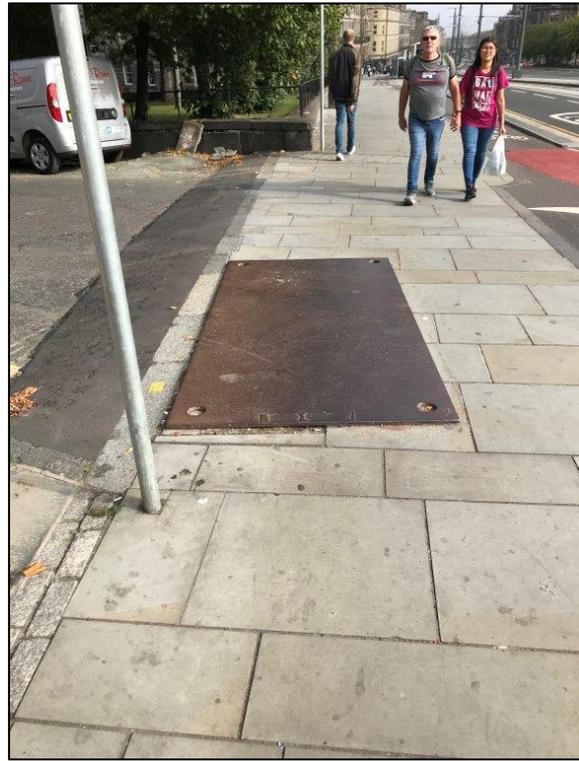
**Summary:** Risk of pedestrians tripping on metal plate, resulting in them sustaining personal injuries.

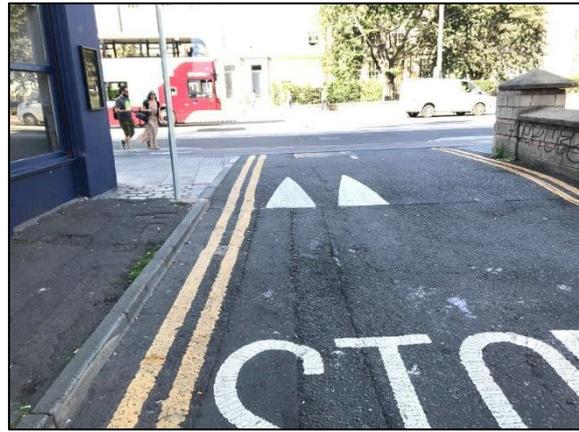
**Summary:** Risk of vehicles failing to stop due to absence of stop line, resulting in them striking crossing non-motorised users or emerging into the path of oncoming vehicles.

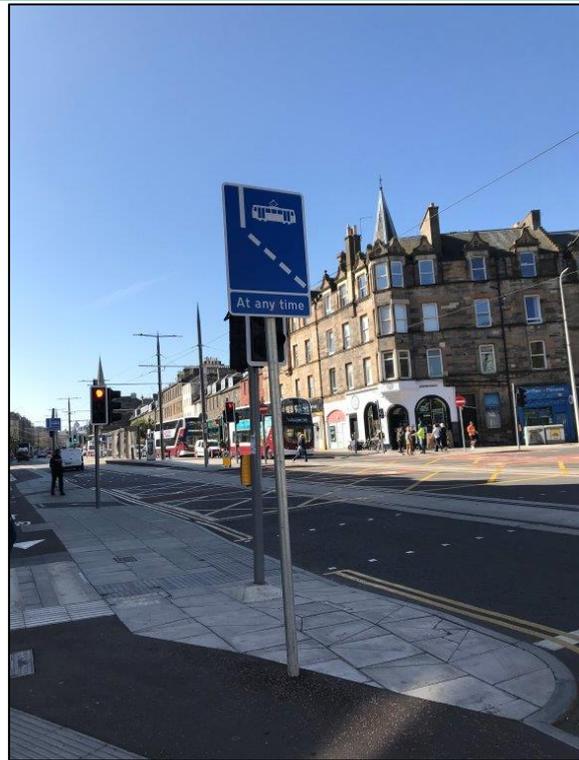
**Summary:** Risk of vehicles failing to stop at stop line due to signal head being obscured by sign face, resulting in them striking and injuring crossing non-motorised users or colliding with other vehicles.

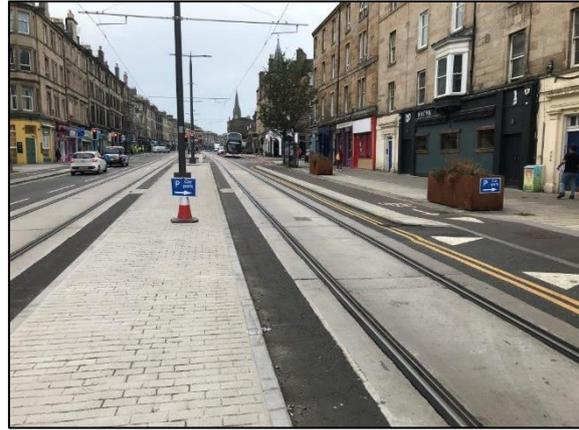
**Summary:** Risk of vehicles on southbound carriageway crossing central reserve and colliding with a tram or a northbound vehicle, due to signage of car park on west side of road.

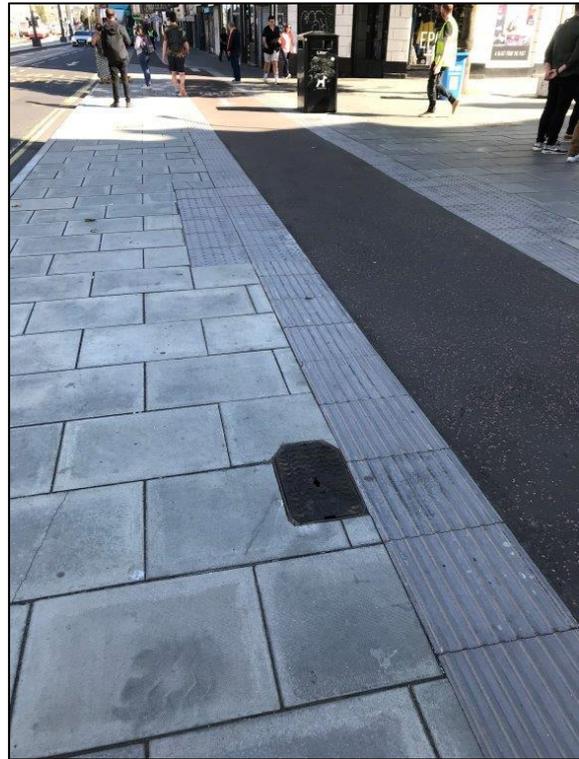
**Summary:** Risk of cyclists failing to slow and / or give way to crossing pedestrians, resulting in them striking and injuring crossing pedestrians, due to absence of mini zebra road markings.

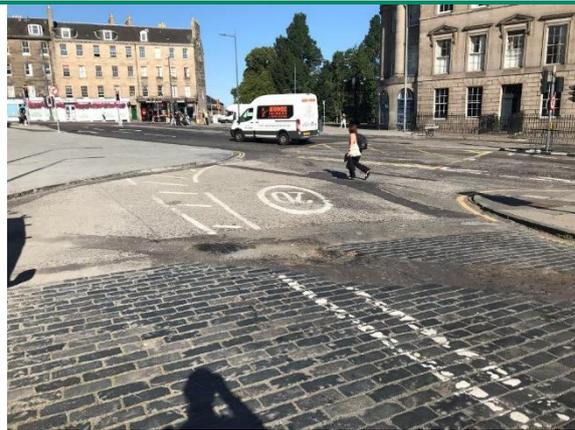
**Summary:** Risk of westbound vehicles colliding with kerb and losing control, or mounting footway and striking and injuring pedestrians, due to confusing provision of road markings.

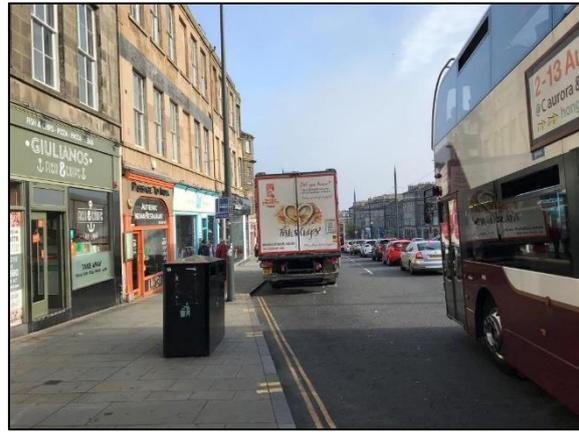
**Summary:** Risk of vehicles making sharp lane changes resulting in side-swipe collisions, due to restricted visibility to tram lane sign.

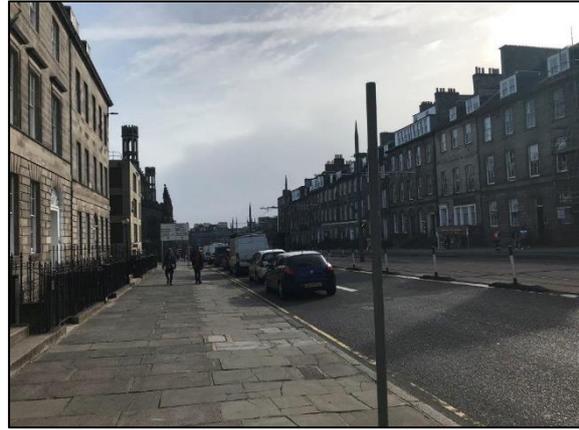
**Summary:** Risk of vehicles making sharp lane changes resulting in side-swipe collisions, due to absence of signage of bus lane.

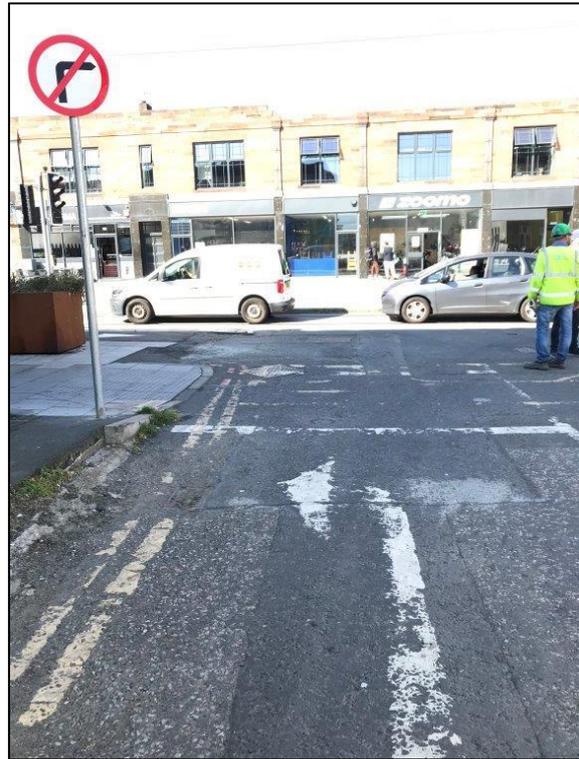
**Summary:** Risk of vehicles failing to stop at stop line, resulting in them emerging onto Leith Walk and being struck by passing vehicles, due to road markings being worn.
