Technical Note No. 5 – Geotechnical

Date:	18 May 2025	Prepared by:	CC
Project name:	Trams to Granton, Bioquarter and beyond	Reviewed by:	GKD
Project no:	B2340264

Comment on Roseburn Cutting (Coltbridge Viaduct and Craigleith Drive)

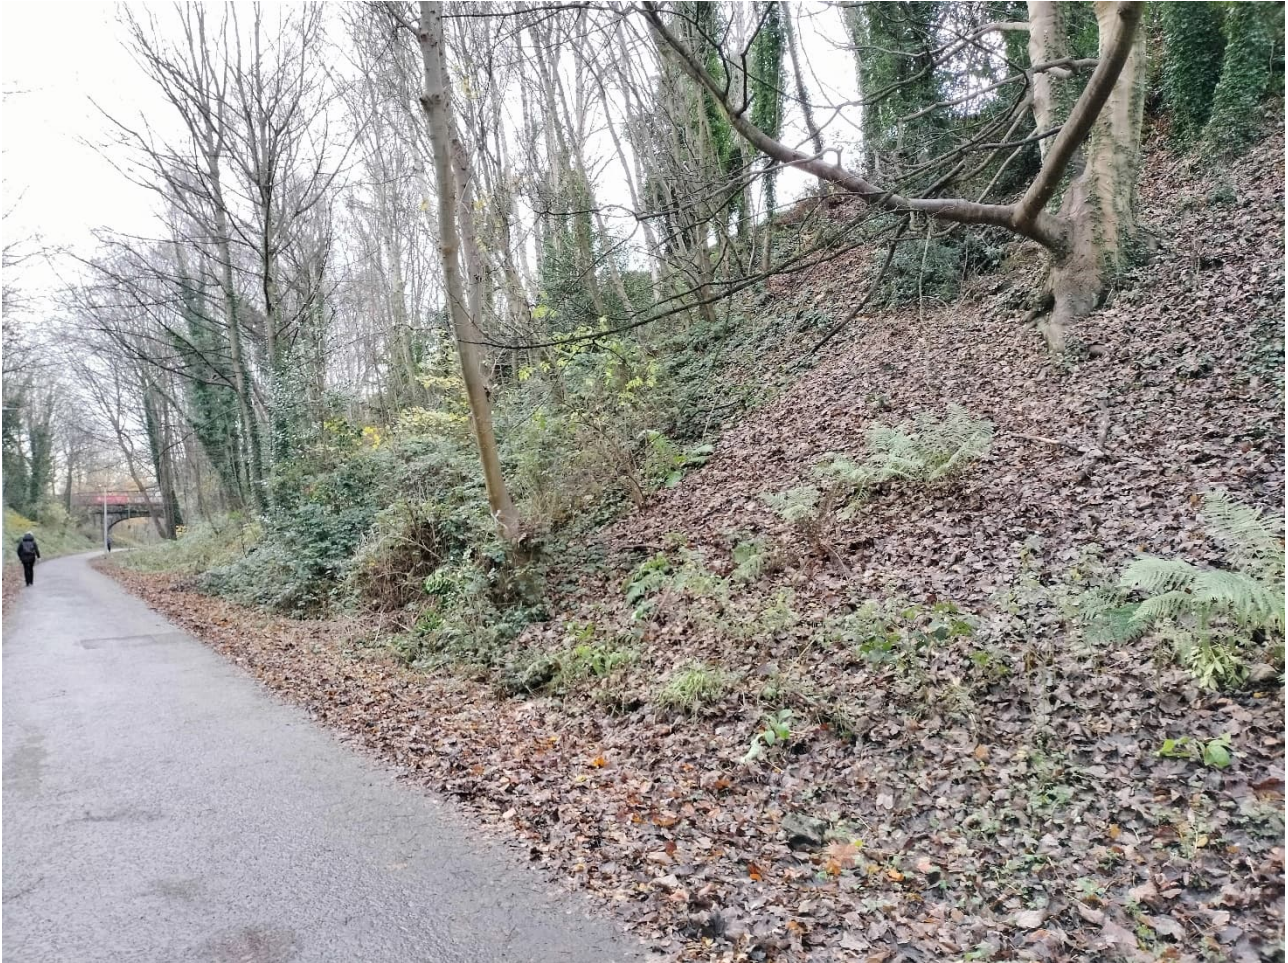
The slopes are heavily vegetated with mature trees, bushes and shrubs, the root systems of which are likely helping to reinforce the slopes. The image overleaf shows the types of vegetation present and gives an indication of the steepness of the slopes. If the vegetation was stripped, the exposure of the slope to direct rainfall and increased percolation into the soil may negatively impact the short term stability of the slope.

If the slopes are generally to be left undisturbed and the majority of the vegetation retained, it is recommended that surveys be undertaken to identify, assess and, if necessary, arrange for controlled removal of dead, diseased or dangerous trees to eliminate the risk of them falling onto the corridor, potentially causing injury, damage to infrastructure and disturbance to the slope by ripping up the roots. Furthermore, it would be helpful to identify the types of trees present and whether their root systems are deep or shallow, to assess how they are impacting on slope stability and whether they could pose an increased risk of falling during high winds due to lack of root support.
