Report type: Photographic Survey
Report No. 4692

23 Seafield Road East, Edinburgh

Photographic Survey

Report No. 4692

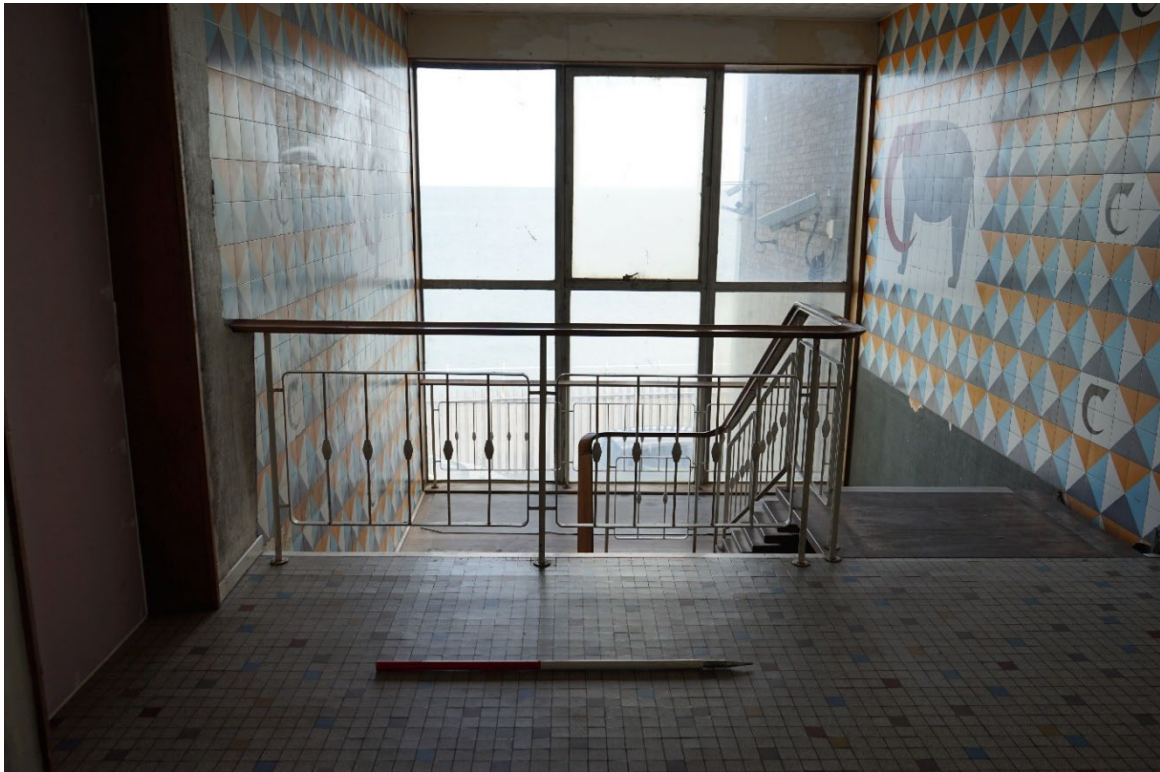
Plate 1. General view of the stairwell

The elephant murals are situated within a stairwell at the back of the building (Plate 1) Fig.2. They are attached to the side walls of the staircase and there is a large window overlooking the sea formed of six panels. The stairs treads and half landings were originally timber, but the lower landing and bottom flight have been replaced with checker plate. The stairs are fitted with a decorative banister (Plate 2). The handrail is varnished wood with decorative metal panels and posts painted cream. The upper landing and ground floor have a tiled surface made of

By the 1960s Mid Century Modern (MCM) was the predominant design style. The style used natural materials such as pale timbers along with lighter or thinner looking fittings, (Plate 1& Plate 2), as a reaction to the dark woods and chunkier, highly decorated earlier Victorian/Edwardian style. MCM also used a lighter colour palette and made use of simple geometric patterns again as a reaction to the earlier, darker Victorian/Edwardian palette and its overly intricate designs. Pastels and oranges as accents against pale off whites were preferred, this can be seen in the murals use of sky blue and yellow ochre (Plate 3) and again reflected in the tiled floor (Plate 4).

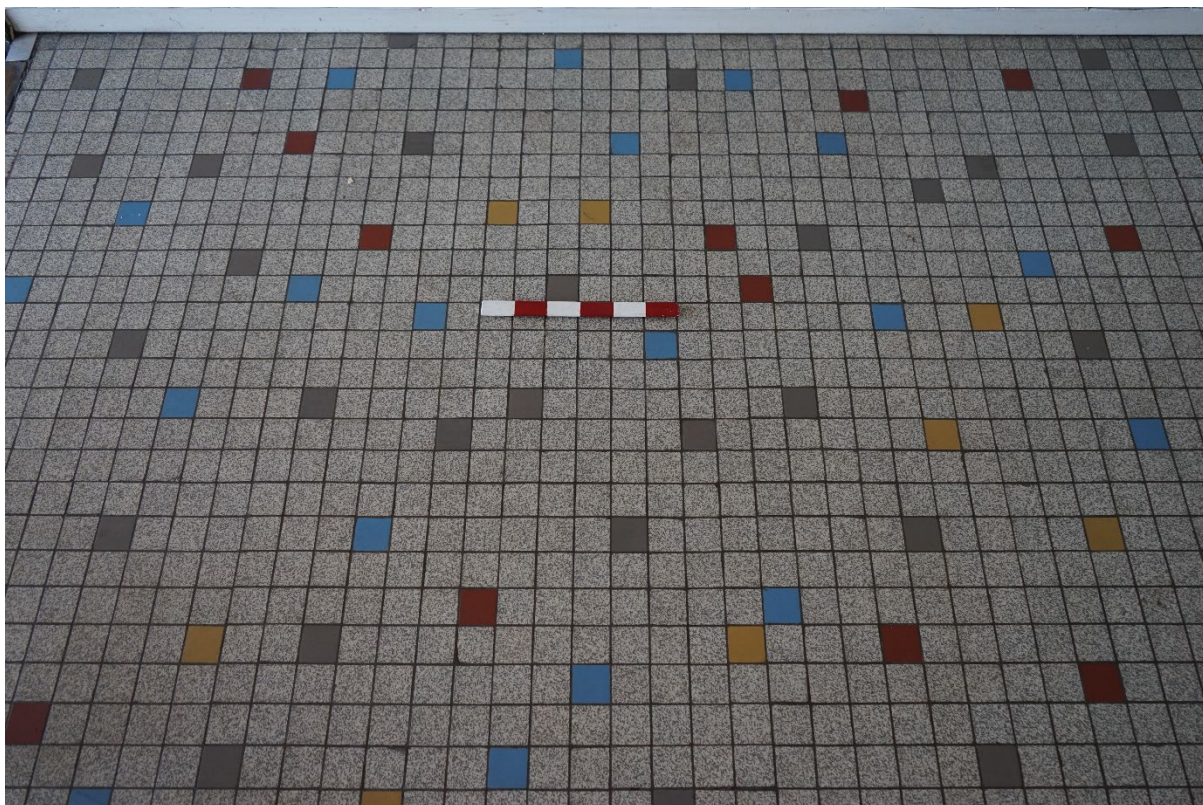
Plate 3. Tiled floor surface

small square ceramic tiles (Plate 3). Most of the tiles have a speckled grey finish with randomly located red, mustard, blue and grey tiles replicating the colours in the murals (Plate 4).

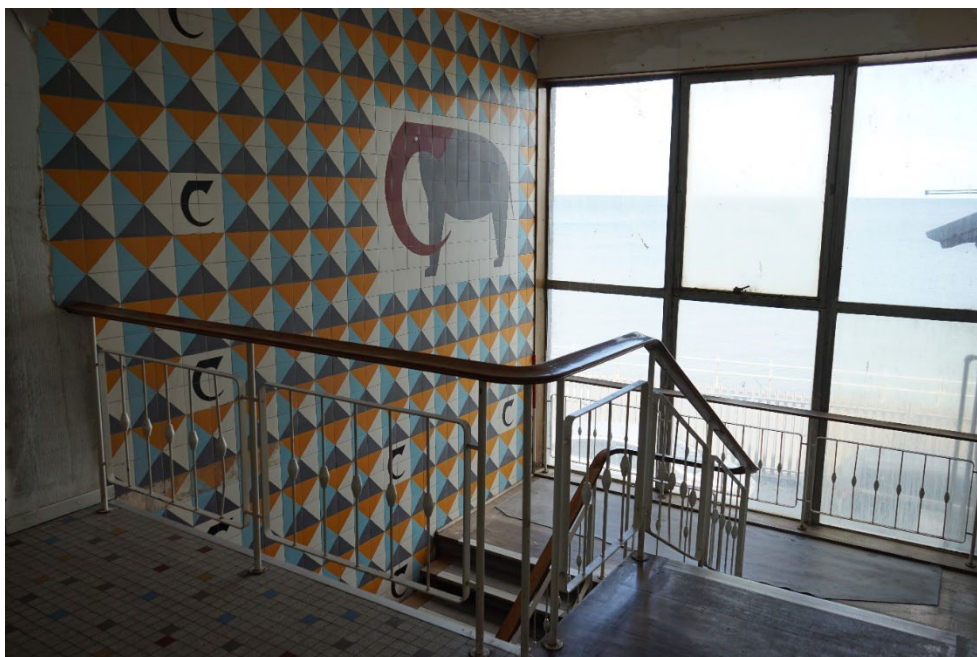
Plate 5. Tiled wall on northwest side

The tiled murals originally covered the southeast and northwest walls of the stair wells (Plate 5 and Plate 6) Fig 3,3.1. It appears they were later covered by wallpaper which has been largely removed. The walls are covered in polychromatic tiles featuring a geometric pattern. Evenly spaced within the design are 4 tiles forming the stylised letter C (Plate 7). The same stylised letter has been used to form the elephant's trunk.
