# Orchard Brae Corridor Dean Bridge Structures Report

The City of Edinburgh Council

July 2025

# Trams to Granton, BioQuarter and Beyond Orchard Brae Corridor - Dean Bridge Structures Report

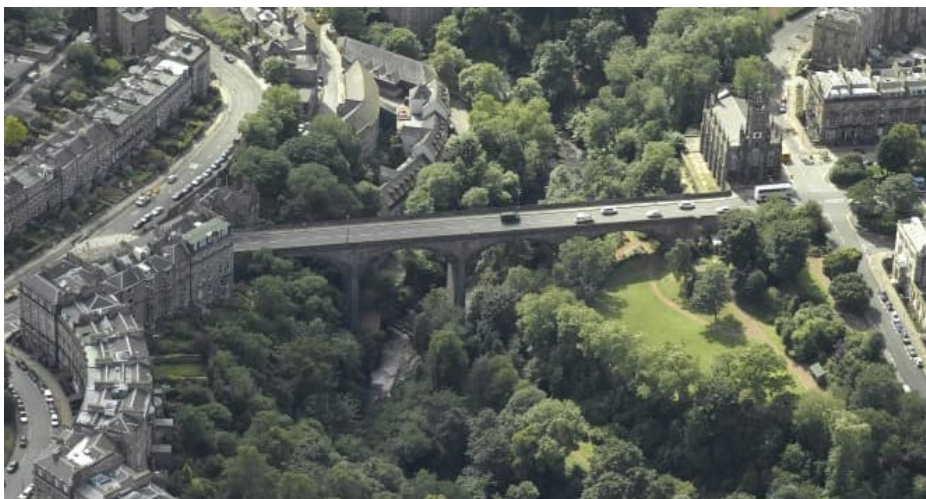
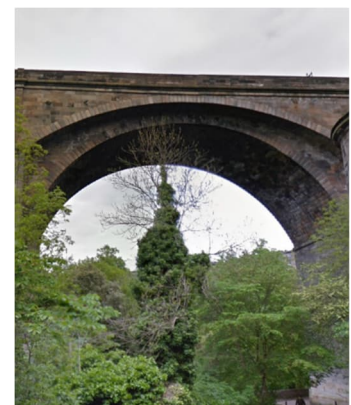
**Figure 4.2: Ariel View of Dean Bridge from the North (LHS), and from Below (RHS)**

The river lies at the base of a deep gorge, therefore the access to the main arches from below is challenging. Figure 4 shows an ariel view of the bridge and its position above the river. There is a footpath beneath the south side of Water of Leith which provides access to the two southern arches. On the north side a large private park is located by the northern arch and pier, with the central pier sitting within the water course.

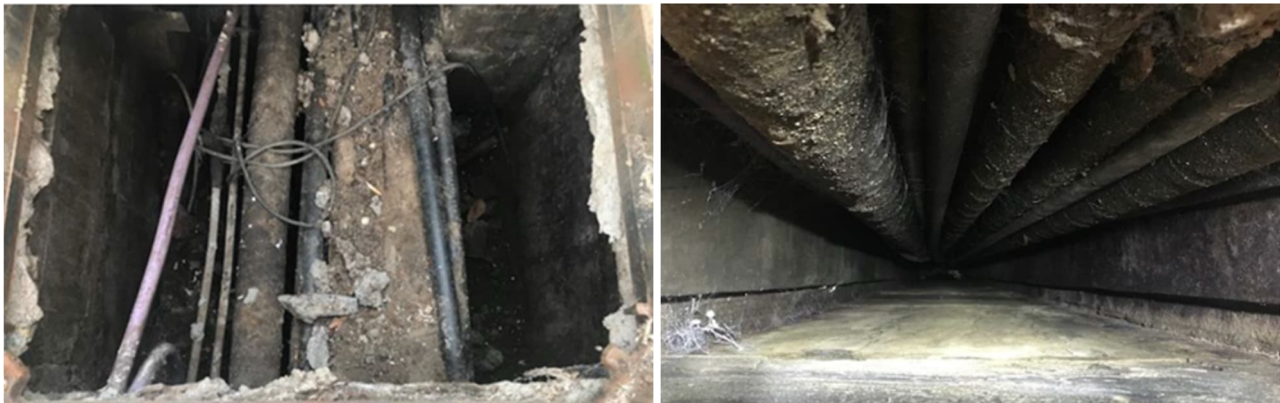
**Figure 4.5: Extracts of the Manhole Access Survey Photos Denoting Utilities and Restrictive Access**

The manhole access survey undertaken in February 2022 noted public utilities ducts in all seven manholes across the structure and these either limited or prevented internal access, as shown in Figure 4.5. The spaces that can be accessed are considered confined and would be restricted to workers with confined space training.
