# Tram Extension, Edinburgh

Ocean Terminal to York Place  
Road Safety Audit Stage 3

The City of Edinburgh Council

Project number: 60651312  
AECOM Reference: RSA/316/S3-A

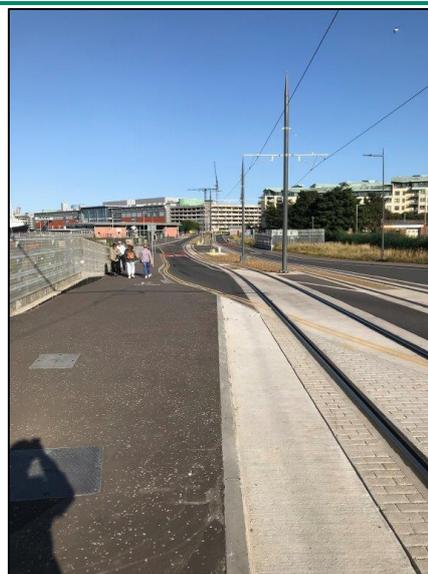
**Summary:** Risk of cyclists falling and being struck by a vehicle, due to crossing tram tracks at an acute angle.

There is concern that the introduction of tram lines throughout the scheme could lead to problems for cyclists at the various junctions and accesses on these roads. The proposals do not include any new infrastructure for cyclists turning across the cycle tracks, other than the two stage right turn infrastructure at the junction of Constitution Street and Queen Charlotte Street.

The Audit Team note the Designer's response comments, however there are still locations where cyclists can choose to travel and where there is a risk that they could cross the tram tracks at a very shallow angle and lose control as a result of a wheel entering the tram track. The above photo shows an example of this on Melrose Drive. The Audit Team retains the above recommendations.

It is recommended that appropriate measures are provided for turning cyclists, so that:

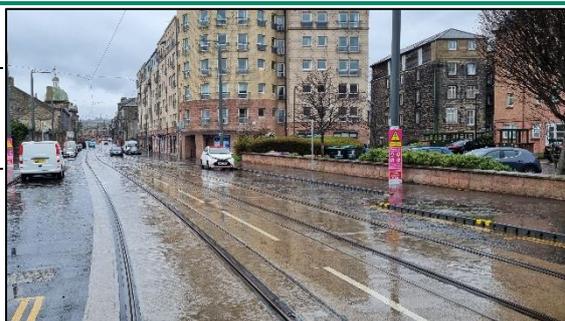
**Summary:** Risk of cyclists falling and being struck by a vehicle, due to crossing tram tracks at an acute angle.

There is concern that the introduction of tram lines throughout the scheme could lead to problems for cyclists, particularly at locations where a single lane is provided for general traffic and the trams. Such locations include Ocean Drive, Ocean Way and Constitution Street. Cyclists travelling parallel to the tram tracks may have to cross the tracks in order to overtake a vehicle stopped along the kerb line or to bypass an obstacle such as a pedestrian, gully, or pothole, and they may do so suddenly and at an acute angle.

Until such time as an alternative route is provided and signed for cyclists, the Audit Team retain their recommendations as above.

It is recommended that appropriate measures are provided to minimise the risk of cyclists slipping or falling on the tram tracks, such as provision of alternative infrastructure or cycle routes.

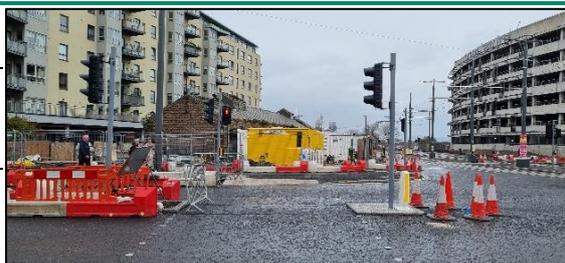
**Summary:** Risk of collisions occurring between vehicles and pedestrians due to long crossing lengths.

There are several locations within the extents of the scheme where long crossing widths are provided. In some cases, no pedestrian refuges are proposed, and in others the refuges do not appear wide enough for a pedestrian to safely wait in the centre of the road. An example is shown in the figure above. There is a risk that the long crossing length and the lack of a suitable refuge could lead to an increased risk of collisions between vehicles and pedestrians, particularly those with visual or mobility impairments.

At the junction of Ocean Drive, Victoria Quay and Melrose Drive, the Audit Team observed that the green man time was very short for some movements. The Audit Team have concerns that this could lead to pedestrians becoming stranded on the central refuges where no push buttons are provided. This could lead to pedestrians crossing when not safe to do so, resulting in them being struck and injured by vehicles.

The Audit Team are still concerned that this is an issue and retain the previous recommendation.

It is recommended that crossing lengths are minimised, refuges are provided where appropriate, and that pedestrians are given an appropriate length of time to cross.

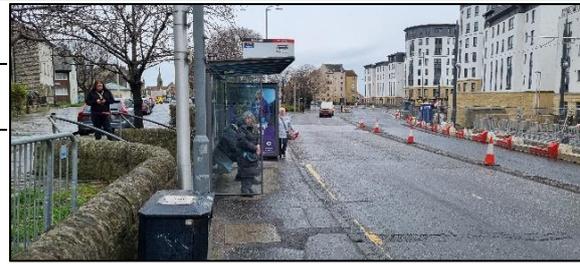
**Summary:** Risk of pedestrians stepping onto the carriageway to bypass the bus shelter and people waiting at the bus stop and being struck by a passing vehicle.

On Lindsay Road, north of No. 14 Annfield, a bus shelter is provided at the bottom of a flight of steps, as shown in the photograph above. This shelter acts as a pinch point on the footway. The proposals appear to include the removal of the footway on the north side of Lindsay Road, although it does appear that a footway will be provided to the north of the tram lines.

The pinch point caused by the location of the bus shelter could lead to pedestrians having to step onto the carriageway at busy periods. This could lead to them being struck by a passing vehicle and sustaining a personal injury. This issue could be exacerbated by the introduction of the tram stop and the closure of the footway on the north side of the carriageway, as this could lead to more pedestrians walking on the southern footway on Lindsay Road.

The Audit Team are still concerned that this is an issue and retain the previous recommendation.

It is recommended that measures are implemented to remove this pinch point, such as relocation of the shelter, provision of a shelter with a smaller cross-sectional area, provision of a cantilever shelter, or widening of the footway.

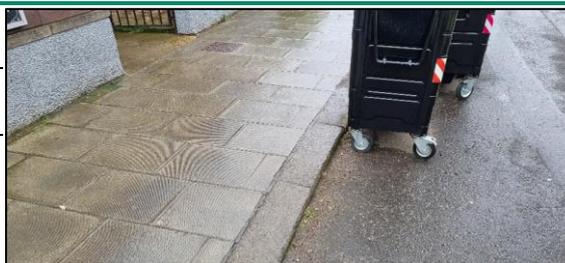
**Summary:** Risk of pedestrians tripping and falling and sustaining a personal injury.

To the east of the bus stop and the wall on the south side of Lindsay Road there is a level difference where the footway on Annfield meets the footway on Lindsay Road, as shown in the photograph above. There is a risk that pedestrians, particularly those with visual impairments, could trip and fall due to the level difference, and sustain a personal injury.

The Audit Team are still concerned that this is an issue and retain the previous recommendation.

It is recommended that appropriate tactile paving is provided along the length of the section of footway where there is a level difference, in order to warn pedestrians of the difference in levels.

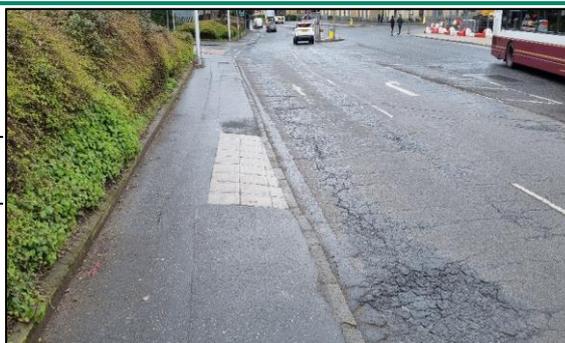
**Summary:** Risk of a visually impaired pedestrian becoming stuck on the carriageway and being struck and injured by a passing vehicle, due to existing tactile paving and dropped kerb not being removed.

During the site investigation it was noted that there are the remnants of an uncontrolled crossing point on the south side of Lindsay Road, east of its junction with Sandpiper Drive. The crossing infrastructure appears to have been removed on the north side of the road, but tactile paving and dropped kerbs remain on the south side.

The Audit Team retain their belief that this is an issue. During the site investigation it was noted that there are the remnants of an uncontrolled crossing point on the south side of Lindsay Road, east of its junction with Sandpiper Drive. If the arrangement is not removed, there is a risk of visually impaired pedestrians attempting to cross at this location, becoming stuck on the carriageway and being struck and injured by passing vehicles.

The Audit Team are still concerned that this is an issue and retain the previous recommendation.

It is recommended that the dropped kerbs and tactile paving at this location are removed.

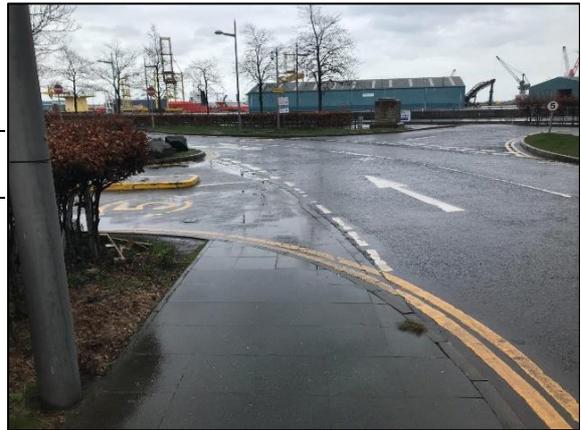
**Summary:** Risk of pedestrians tripping and falling when attempting to transition between the footway and carriageway, resulting in them sustaining a personal injury, due to lack of pedestrian crossing facility and abrupt end of footway.

As shown in the image above, the proposed footway on the north-west side of Ocean Drive does not lead anywhere. No crossing facility appears to be provided at the access to the Ocean Terminal outside car parking facility and no further pedestrian infrastructure appears to be proposed.

The Audit Team are still concerned that this is an issue and retain the previous recommendation.

It is recommended that suitable infrastructure is provided to allow pedestrians to continue their journey, such as an appropriate crossing point.

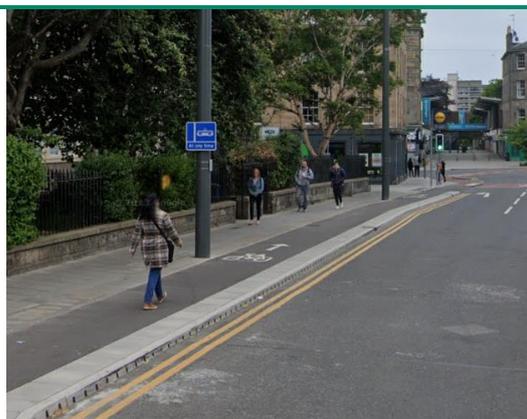
**Summary:** Risk of pedestrians or cyclists colliding with street furniture resulting in personal injury.

New traffic signs, street lighting columns and other street furniture have been installed throughout the project extents. Due to the lack of colour contrasting banding on the traffic signal posts, traffic signposts, pedestrian guardrail, street furniture and street lighting columns, visually impaired non-motorised users may not be able to differentiate the safest route and could collide with these resulting in personal injury.

The Audit Team are still concerned that this is an issue and retain the previous recommendation.

It is recommended that suitable contrast banding is applied to all street furniture.

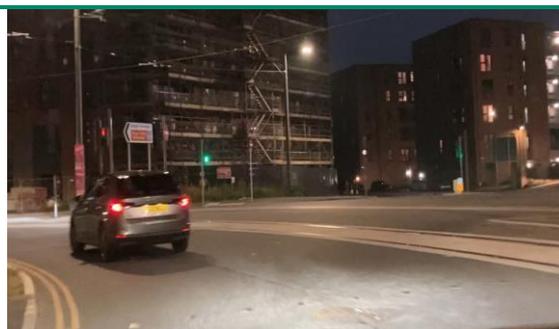
**Summary:** Risk of vehicles undertaking a sudden lane change upon inadvertently entering tram lane, resulting in side-swipe collisions occurring.

The Audit Team retain their belief that this is an issue. The drivers / riders of vehicles turning onto Ocean Drive, particularly those from Victoria Quay, could inadvertently enter the tram lane and make a lane change upon realising that they are in the wrong lane, leading to side-swipe collisions occurring with vehicles in the nearside lane. It should be noted that during the site investigation the road markings through the junction had not been provided.

It is recommended that the design is appropriately amended so that is clear to the drivers / riders of approaching vehicles which lanes they can travel in and which they cannot.

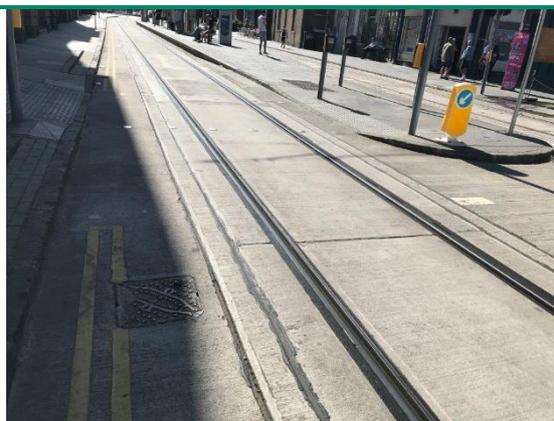
**Summary:** Risk of cyclists falling and being struck by a vehicle, due to crossing tram tracks at an acute angle to overtake or bypass obstacles.

There is concern that the introduction of tram lines throughout the scheme could lead to problems for cyclists, particularly at locations where a single lane is provided for general traffic and the trams. Such locations include Ocean Drive, Ocean Way, and Constitution Street. Cyclists travelling parallel to the tram tracks may have to cross the tracks in order to overtake a vehicle stopped along the kerb line or to bypass an obstacle such as a pedestrian, gully, or pothole, and they may do so suddenly and at an acute angle. Carrying out such manoeuvres could result in cyclists slipping on the tram tracks and falling or getting their wheel(s) stuck and falling. If a cyclist was to fall from their bicycle, there is a risk that they could be struck by a passing vehicle

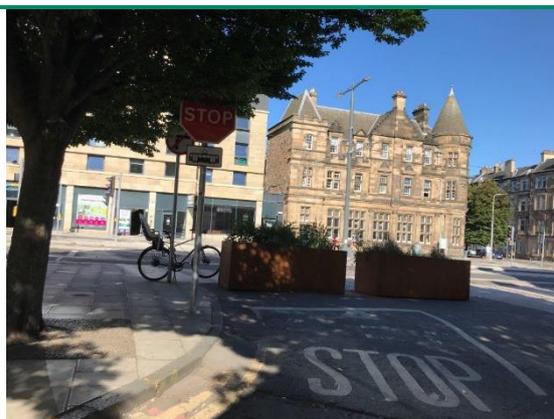
**Summary:** Risk of cyclists colliding with pedestrians whilst attempting to transition between the carriageway on a stopped-up street and the cycle infrastructure or the mainline carriageway, due to no infrastructure being provided to facilitate this transition.

Secondary risk of vehicles attempting to defy the 'no through road' restriction and colliding with pedestrians or cyclists whilst doing so.

There are several locations throughout the scheme extents where the proposals include the stopping up of side roads, with 'no through road except cycles' signage (Diagram 816, TSRGD 2016) being proposed.

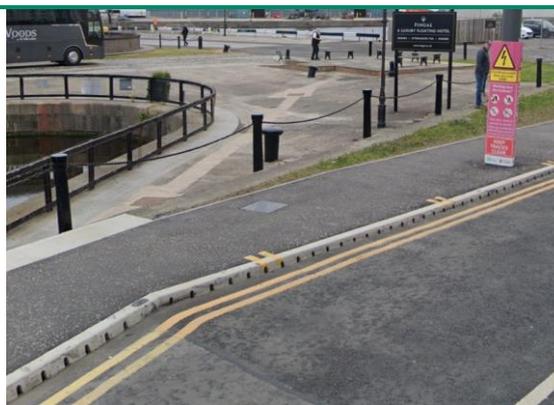
**Summary:** Risk of pedestrians slipping or tripping and sustaining a personal injury.

A pedestrian crossing is proposed across Ocean Drive, approximately 50 metres west of the junction of Ocean Drive and Tower Place. At the proposed crossing location, there is not currently a footway on the north side of the road. An area of hard standing exists to the rear of the grass verge, although there is a level difference between this area and the verge. A post and chain fence acts as a barrier between these two areas.

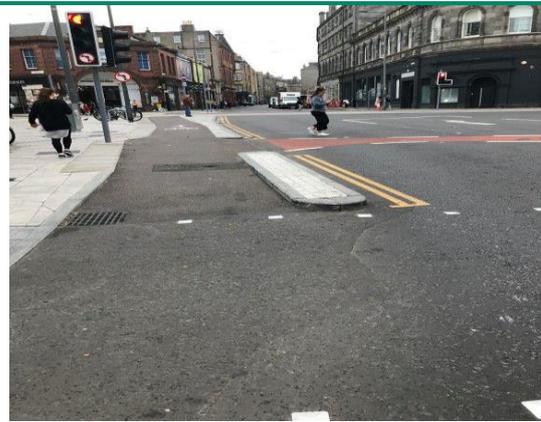
**Summary:** Risk of vehicles colliding with kerb lines at the commencement of segregated cycleways due to these being inconspicuous, resulting in injuries to vehicle occupants / riders.

Segregated cycleways are proposed on both sides of Leith Walk. The segregation starts and ends at various locations along the street, such as at the northern and southern extents of Leith Walk and at several of the junctions.

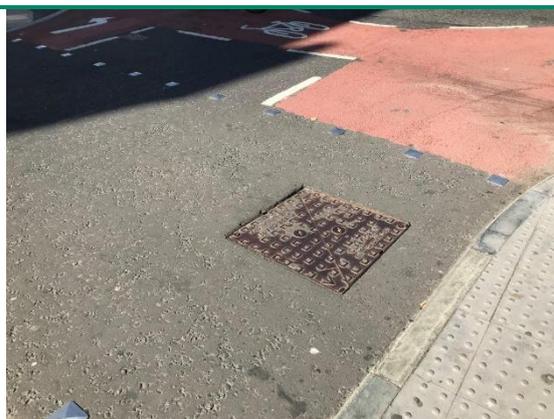
**Summary:** Risk of non-motorised users tripping and falling on ironwork protruding from footway surface, resulting in them sustaining personal injuries.

Risk of vehicles losing control when travelling over ironwork protruding from the carriageway surface, resulting in them striking other vehicles or street furniture.

The scheme includes areas of new pavement and footway construction. At many of these locations existing ironwork is present. In the plans provided to the Audit Team it is unclear if the ironwork will be raised / lowered to be flush with the adjacent surface.

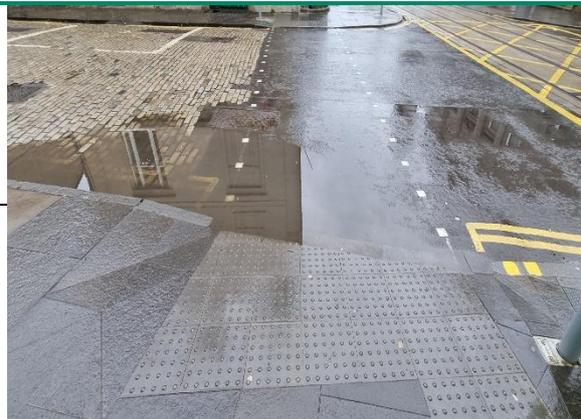
**Summary:** Risk of vehicles skidding and losing control due to surface water pooling on carriageway at interfaces between ramps and existing carriageway.

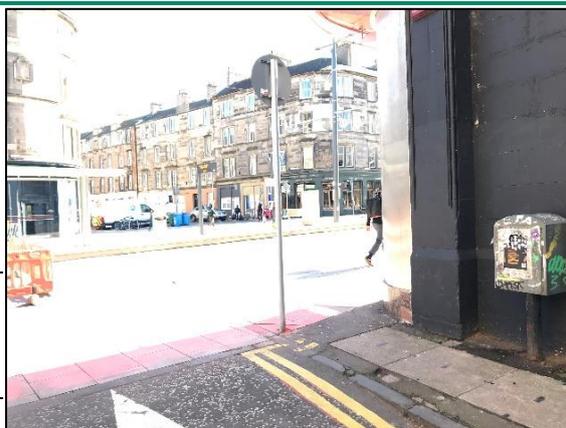
**Summary:** Risk of vehicles emerging from side road / access when it is not safe to do so due to visibility being obscured at proposed locations of give way markings, leading to side impact collisions with vehicles on Leith Walk or emerging vehicles striking and injuring non-motorised users.

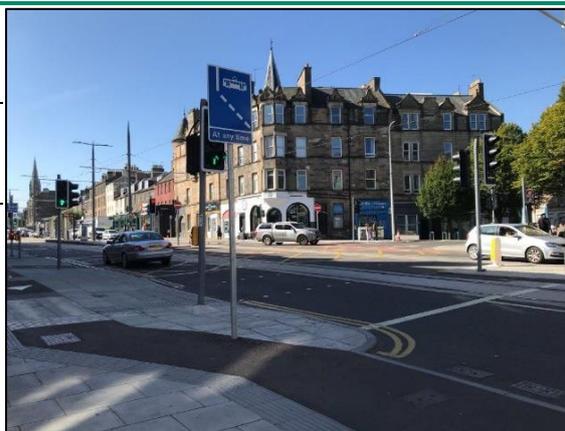
**Summary:** Risk of vehicles striking and injuring crossing pedestrians due to proximity of signalised junction to side road junction.

A signalised junction is proposed at the junction of Leith Walk and Balfour Street, immediately downstream from Jameson Place at its junction with Leith Walk. There is concern that the drivers / riders of vehicles on Jameson Place may be unaware of the position of the signalised junction when emerging from Jameson Place. It is likely that they will be looking towards oncoming traffic to the right for an appropriate gap to emerge into. The short distance between the side road junction between Jameson Place and Leith Walk and the signalised junction of Leith Walk and Balfour Street means they are unlikely to have sufficient time to observe and respond to a red-light signal at the signalised junction. This increases the risk of vehicles colliding with non-motorised or a turning vehicle.

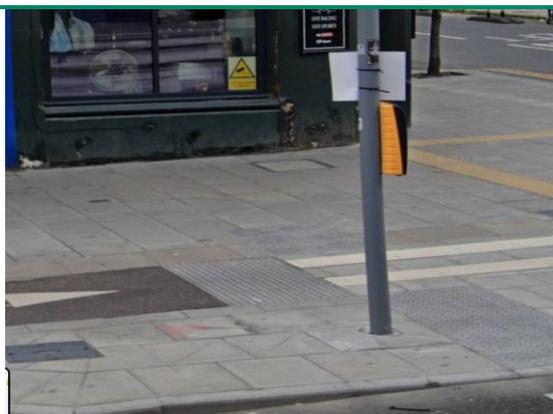
**Summary:** Risk of visually impaired pedestrians entering the carriageway when it is not safe to do so and being struck and injured by passing vehicles, due to confusing environment and tactile paving provision.

A pedestrian crossing is proposed across Leith Walk north of its junction with Lorne Street. The proposed tactile paving arrangements at the crossing do not include a stem.

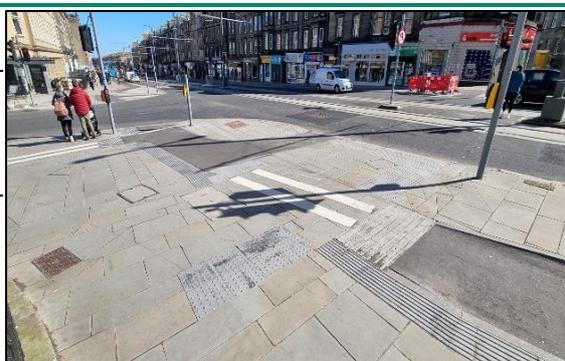
**Summary:** Risk of pedestrians encroaching into cycleways and being struck and injured by cyclists due to unclear delineation of cycleways.

The proposals on Leith Walk include several locations where the cycleways appear to ramp up to footway level to enable pedestrians to cross them.

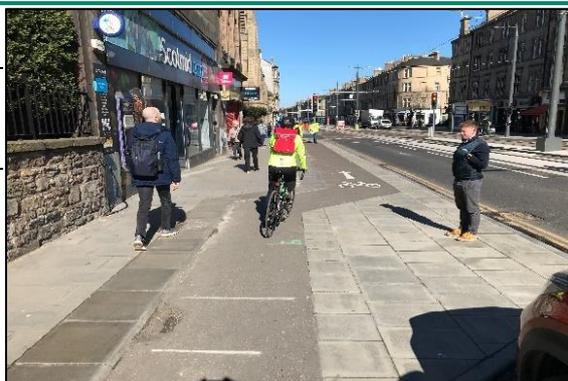
**Summary:** Risk of cyclists losing control due to geometry of cycleway, resulting in them falling and sustaining personal injuries.

The proposed layout of the cycleways on Leith Walk appear to include many tapers on which radii do not appear to be proposed. The Audit Team have concerns that users on different types of bicycles (such as a cargo bike, recumbent bike or tandem) may have difficulties using the cycleways due to these changes in horizontal alignment. This could result in users losing control, and colliding with a kerb and falling, resulting in them sustaining personal injuries.

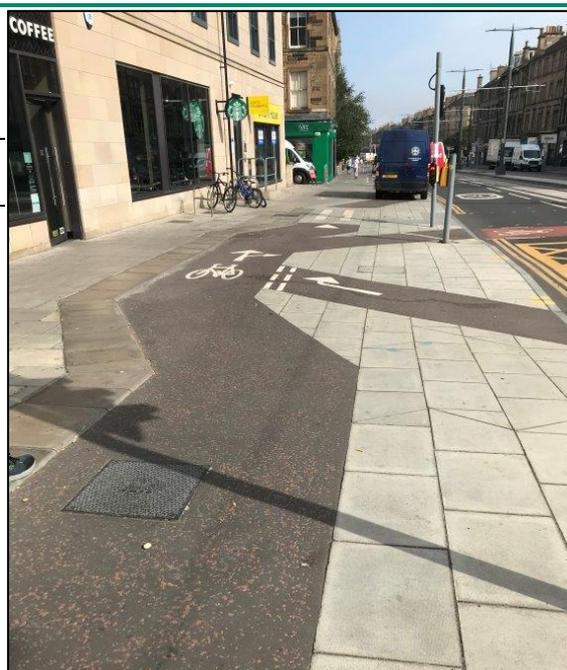
**Summary:** Risk of pedestrians stepping onto the cycleway and being struck and injured by passing cyclists due to restricted footway width.

In the plans provided to the Audit Team it is unclear what footway width is to be provided on the western footway on Leith Walk between Shrubhill Walk and Middlefield. As shown in the image on the left above, the drawings appear to show the footway being narrowed.

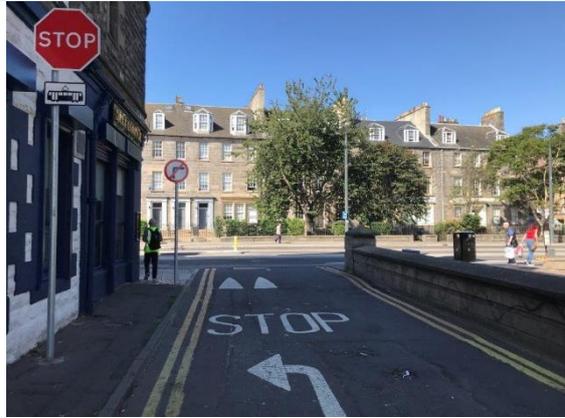
**Summary:** Risk of vehicles emerging from side roads / accesses when it is not safe to do so due to the position of the stop signs, leading to them striking and injuring non-motorised users or striking other vehicles

The proposals include stop signs on many of the side roads within the extents of the scheme. These are set back significantly from the junction, as shown in the example in the image above on the left (at the access to the private NHS car park on Leith Walk and accesses to 165 Leith Walk).

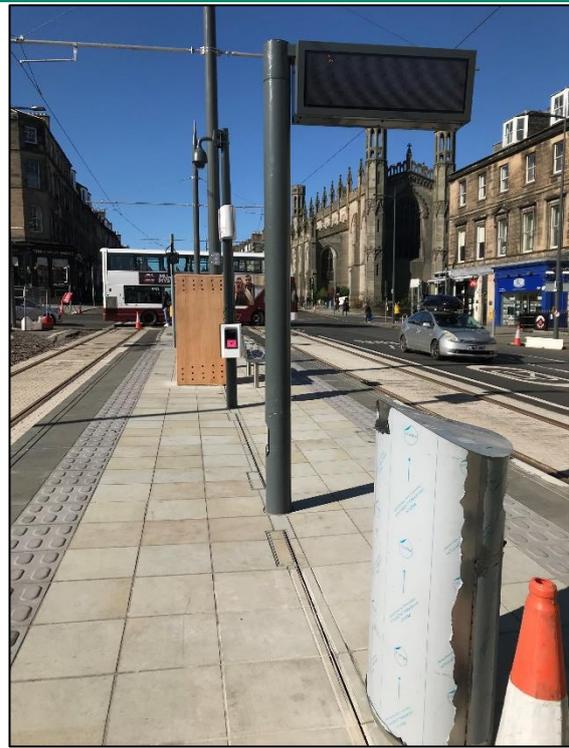
**Summary:** Risk of pedestrians or cyclists colliding with street furniture, resulting in personal injury.

New traffic signs, street lighting columns and other street furniture are proposed throughout the project extents. Due to the apparent lack of colour contrasting banding on the traffic signal posts, traffic sign posts, pedestrian guardrail, street furniture and street lighting columns, visually impaired non-motorised users may not be able to differentiate the safest route and could collide with these, resulting in personal injury.

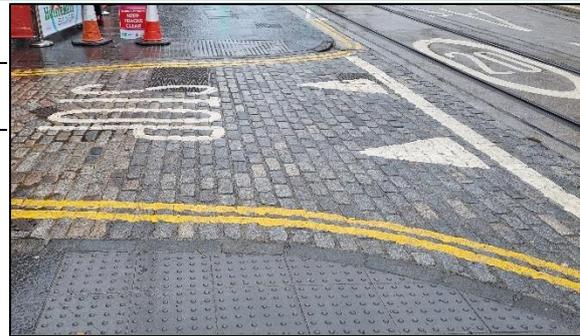
**Summary:** Risk of vehicles proceeding contrary to direction of traffic flows on one-way streets, resulting in head on collisions, due to provision of road markings.

In the plans provided to the Audit Team it appears that road hump triangle markings (to Diag. 1062, TSRGD 2016) are proposed on both sides of the raised crossings on Maritime Lane at its junction with Constitution Street. Maritime Lane is one-way on both sides of Constitution Street and vehicles cannot turn into Maritime Lane from Constitution Street.

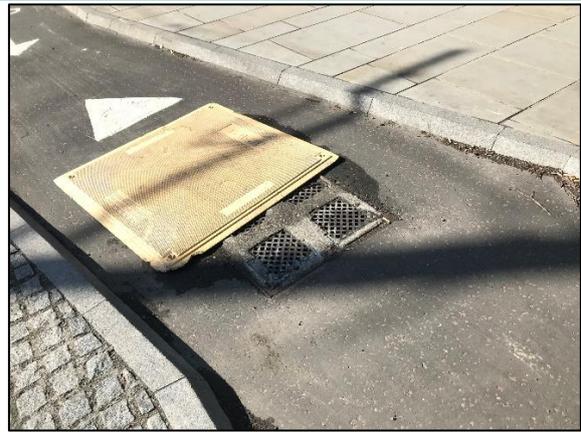
**Summary:** Risk of cyclists becoming unseated due to statutory undertaker covers provided in cycleway not being flush with surrounding surface.

As shown in the photograph above, statutory undertaker covers are provided in the cycleway to the south of the exit of Gayfield Square at Leith Walk. These statutory undertaker covers are not flush with the surrounding surface of the cycleway.

It is recommended that the statutory undertaker covers are flush with the surrounding surface.

As this problem still exists, the Audit Team have retained this recommendation.

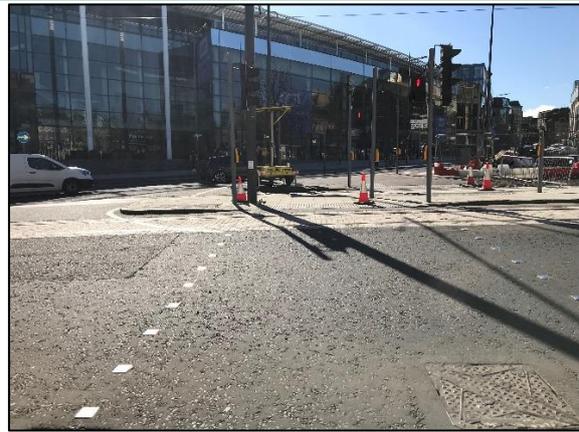
**Summary:** Risk of pedestrians crossing when not safe to do so due to "see through", resulting in them being struck and injured by passing vehicles.

The Audit Team have concerns regarding the risk of see through at Picardy Place tram stop. As shown in the photograph above, a pedestrian crossing between the tram stop and the traffic island to the south can see the pedestrian aspects for both crossings. Whilst these crossings do both get a green aspect during one stage, in another stage the crossing across the eastbound tramline displays a green man whilst that across the westbound tramline is shown a red man.

It is recommended that appropriate measures are provided to reduce the risk of see through.

It was noted on site that louvres have been added to the green man signals on the north side of the crossing however there is still an issue with see-through from the crossing point on the Omni Centre side. It is recommended that a further louvre is fixed to resolve this.

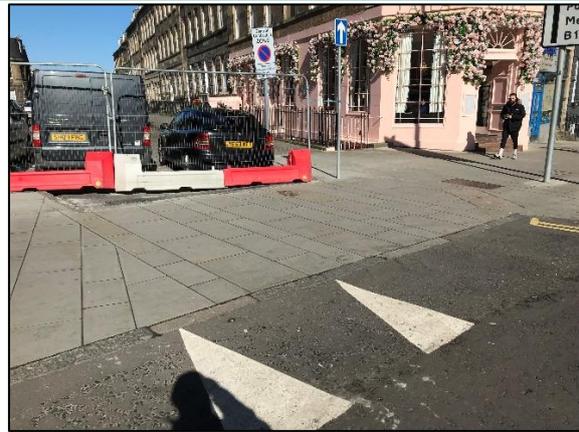
**Summary:** Risk of vehicles cutting across footways / cycleways and striking non-motorised users or street furniture due to lack of guidance of path through junctions.

Continuous footways are provided at many of the junctions of Leith Walk and its side roads. Many of the footways at these continuous footways are wide and vehicles crossing the continuous footway have to cross the footway itself as well as the cycle track.

During the site visits, the Audit Team witnessed a number of vehicles entering Leith Walk from side roads and having to “bump” down onto Leith Walk as they had failed to follow the direct route using the ramps provided to allow the correct transition.

The Audit Team observed numerous instances of vehicles cutting the corners at some junctions and there is evidence of damage to the surface / slabs which supports this problem. From the Audit Team’s perspective, the previous recommendation still stands.

It is recommended that appropriate measures are provided to guide vehicles across the continuous footway to the ramp opposite.

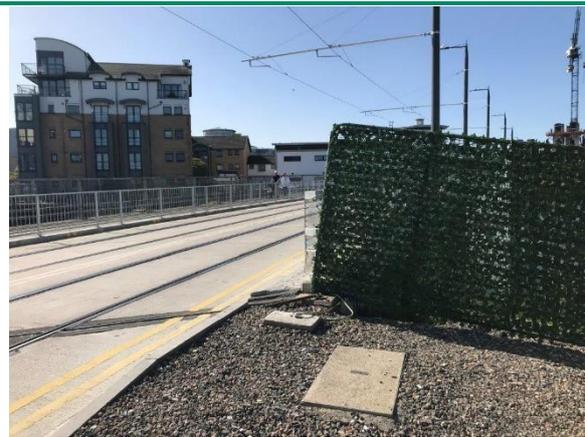
**Summary:** Risk of rear end shunts or side impact collisions between motorised vehicles due to constrained forward visibility to access.

Two accesses are provided on the north side of Ocean Drive to the east of the Water of Leith. These accesses are provided on the inside of a bend, with a parapet being provided on the north side of the road.

It is noted that there is insufficient space at the delivery access to Fingals to allow a vehicle to wait off the carriageway, which exacerbates this issue.

The Audit Team believe that this is still an issue, and the recommendation still stands.

It is recommended that appropriate forward visibility is provided to these accesses.

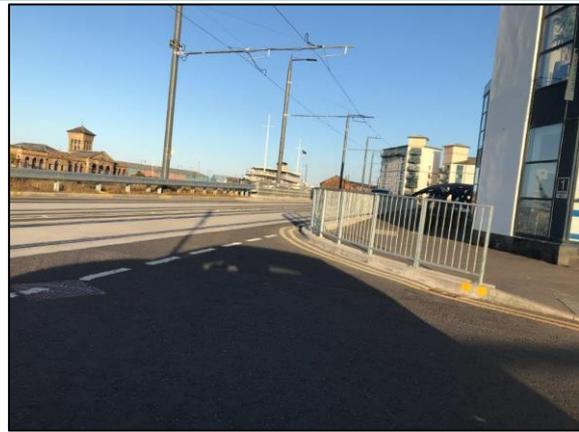
**Summary:** Risk of vehicles emerging from Rennie's Isle when not safe to do so and being struck by vehicles on Ocean Drive due to visibility being constrained by guardrail.

Guardrail is provided at the junction of Rennie's Isle and Ocean Drive, as shown in the photograph above. The Audit Team have concerns that the guardrail could obscure the visibility of drivers / riders turning from Rennie's Isle onto Ocean Drive. This could lead to vehicles emerging when it is not safe to do so and being struck by other vehicles.

During the final Stage 3 site visit, the Audit Team stopped a car at the stop line and observed this view of an approaching vehicle. It is noted that the top of the car can just be seen, however this was a high sided car. The Audit Team are concerned that a smaller or lower car would not be visible and there is therefore still a risk of a conflict if a vehicle pulls out into the path of a vehicle. The Audit Team retain their recommendation to replace the guardrail with high visibility guardrail or consider the removal of the barrier.

It is recommended that high-visibility guardrail is provided.

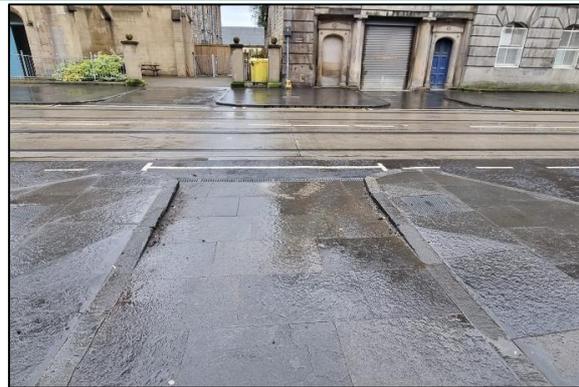
**Location(s):** 2 no. private accesses on west side of Constitution Street, north of Queen Charlotte Street

**Summary:** Risk of vehicles emerging from private accesses when not safe to do so and being struck by vehicles on Constitution Street due to visibility being constrained by parked vehicles.

The Audit Team note the designer's response which is in relation to a possible conflict with a tram, however there is still a risk that a vehicle (such as a car or bicycle) could be travelling closer to the kerbside and conflict with a vehicle exiting the access. The Audit Team retain their belief that this is a problem and recommend that appropriate measures are provided so as to provide an unimpeded visibility splay for vehicles exiting from the private accesses.

It is recommended that appropriate measures are provided so as to provide an unimpeded visibility splay for vehicles exiting from the private accesses.

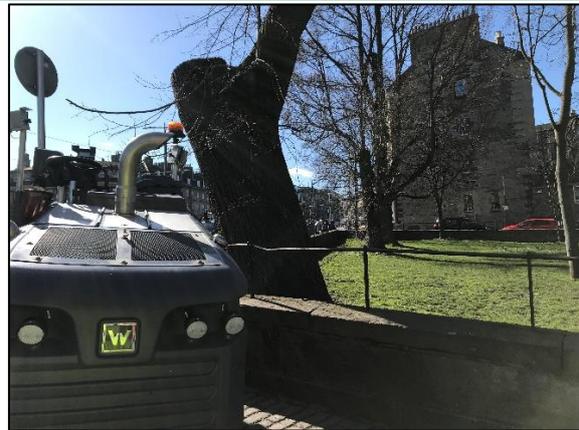
**Summary:** Risk of vehicles emerging from Gayfield Square when not safe to do so and striking and injuring non-motorised users, due to tree obscuring visibility.

Secondary risk of vehicles emerging from Gayfield Square when not safe to do so and being struck by northbound vehicles on Leith Walk, also due to tree obscuring visibility.

As shown in the photograph above, a tree is located to the south of the exit from Gayfield Square at its junction with Leith Walk. The Audit Team have concerns that the tree could obscure visibility for the drivers / riders of vehicles emerging from Gayfield Square.

The Audit Team note the designer's response, however, are still concerned that the visibility for emerging vehicles is severely limited to the footway and cycleway. There is still a risk that a vehicle could pull out into the path of a cyclist resulting in a serious injury to the cyclist. From the Audit Team's perspective, the previous recommendation still stands.

It is recommended that visibility is maximised.

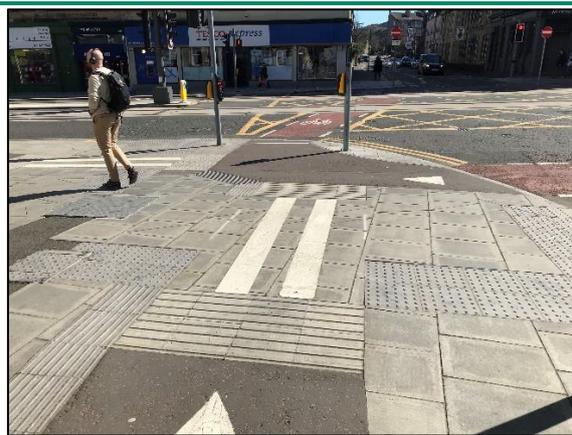
**Summary:** Risk of visually impaired pedestrians becoming confused

There are several junctions on Leith Walk where signalised crossings interact with cycle tracks. At these points, the designer has attempted to introduce tactile paving which warns of:

It is noted that cycle speeds can be high given the gradient of Leith Walk, therefore there is a higher risk of more severe severity of injuries in the event of a collision between a cyclist and a pedestrian.

The Audit Team note the designer's response, however, are still concerned that there are a number of junctions where the layouts are very confusing. This applies to both those with good vision and visually impaired users. Police Scotland commented on the layouts after the Interim Road Safety Audit to suggest that they were rather confusing. The Audit Team therefore retain their belief that this is a problem and the recommendation from the Interim Stage 3 Road Safety Audit.

It is recommended that a simpler layout is provided at these locations which can be easier to understand and reduces the risk of conflict between vulnerable users.

Additionally, it is recommended that City of Edinburgh Council carry out a review of the guidance for the use of tactile paving in discussion with visually impaired user groups in order to simplify the use of tactile paving at these types of layouts.

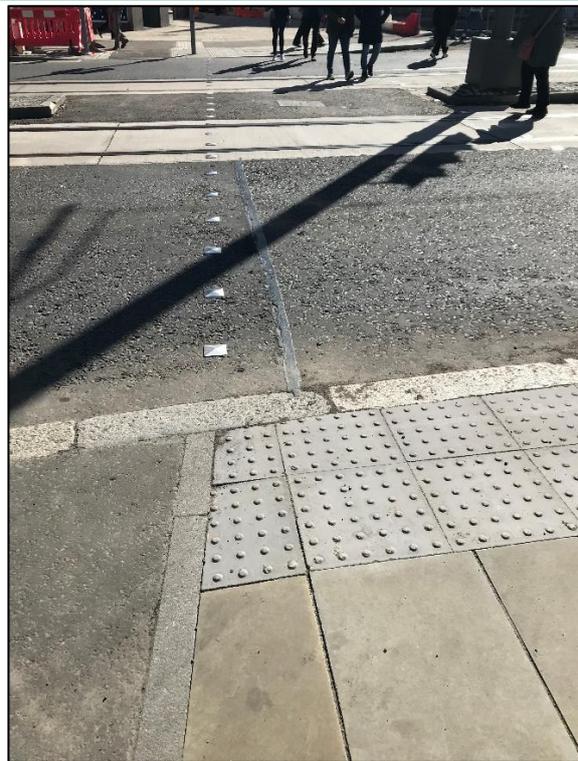
**Summary:** Risk of visually impaired pedestrian becoming stuck on the carriageway, and being struck and injured by passing vehicles, due to tactile paving not aligning on opposing sides of crossing points.

At many locations throughout the extents of the scheme tactile paving has been provided that does not align on either side of crossing points, both controlled and uncontrolled. Affected streets include:

The Audit Team note the designer's response, however, as this is still to be actioned, they retain the previous recommendation.

It is recommended that the dropped kerbs and tactile paving align on opposing sides of crossing points.

NCR's/Defects have been raised and SFN will deal with them if they are out of the design tolerances.

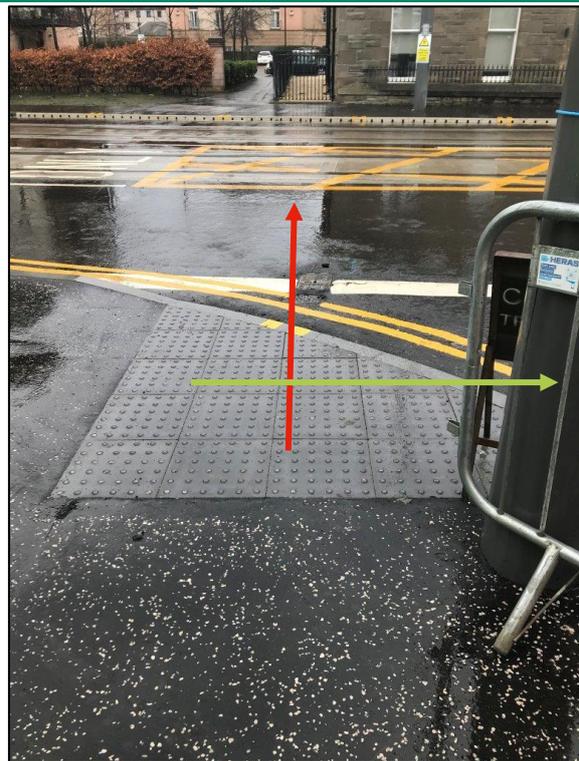
**Summary:** Risk of visually impaired pedestrians misinterpreting tactile paving due to tactiles being positioned on radii, leading to visually impaired pedestrians attempting to cross, becoming stuck on the carriageway, and being struck and injured by passing vehicles.

At several locations throughout the extents of the scheme tactile paving has been positioned on kerb radii. There is a risk that such tactile paving could be misinterpreted by visually impaired pedestrians. An example, from the junction of Tower Place and Ocean Drive shows how the tactile paving could be misinterpreted, with the green arrow showing the intended crossing direction and the red arrow showing how the crossing could be interpreted.

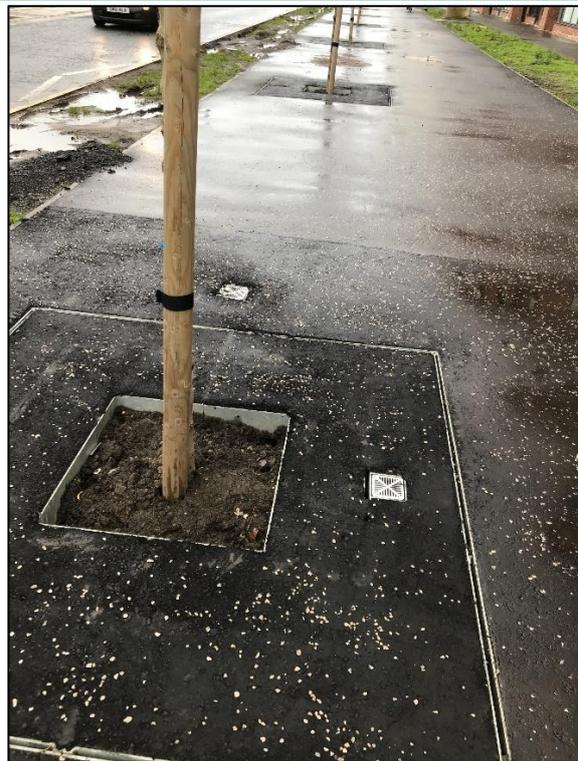
**Summary:** Risk of injury to pedestrians as a result of sunken tree planting in footway.

There are a number of new trees which have been planted along the southern side footway opposite the Ocean Terminal shopping centre, as can be seen in the photograph.

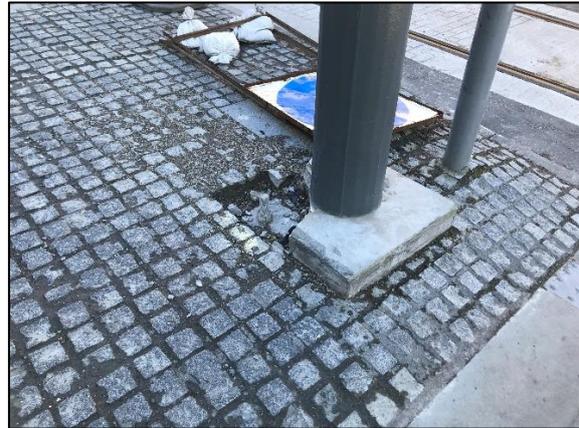
**Summary:** Risk of pedestrians tripping on uneven footway surfaces and sustaining personal injuries.

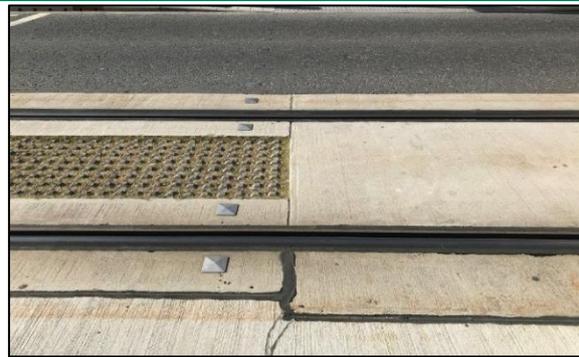
**Summary:** Risk of pedestrians slipping / tripping and falling due to presence of grasscrete within extents of crossing points, resulting in them sustaining personal injuries.

As shown in the photograph above, grasscrete is provided with the crossing extents at the southern crossing of Ocean Drive northbound at Ocean Terminal.

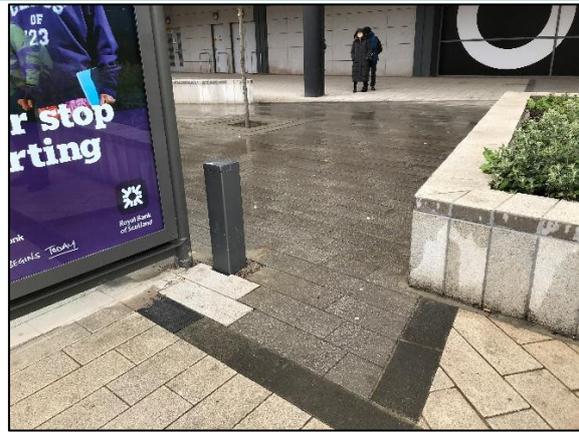
**Summary:** Risk of non-motorised users colliding and sustaining personal injuries due to restricted footway width.

As shown in the image above, the footway next to the bus stop on the north-west side of Ocean Drive at Ocean Terminal is constrained by the bus stop, feeder pillar, and the adjacent wall. There is a risk that non-motorised users could collide at this location, resulting in personal injury.

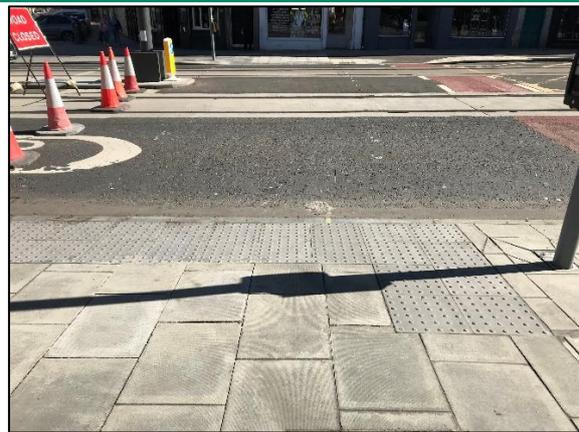
**Location(s):** Leith Walk at Stead's Place, south of Dalmeny Street, north of London Road, north of MacDonald Road and York Place

**Summary:** Risk of visually impaired pedestrians becoming confused or disorientated due to road studs not continuing across the full width of crossings, resulting in them being trapped on the carriageway and struck and injured by passing vehicles.

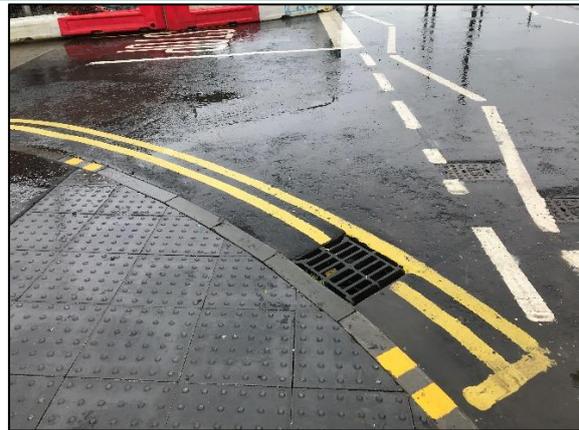
**Summary:** Risk of pedestrians tripping and falling due to presence of gullies within extents of crossing points, resulting in them sustaining personal injuries.

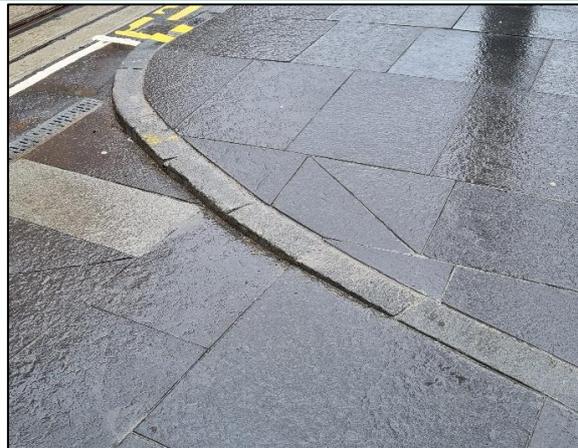
**Summary:** Risk of pedestrians tripping at vehicle crossovers due to surface not being flush with adjacent footways, resulting in the pedestrians sustaining personal injuries.

At several locations the surface of vehicle crossovers are not flush with those of the adjacent footways. This includes at the following locations:

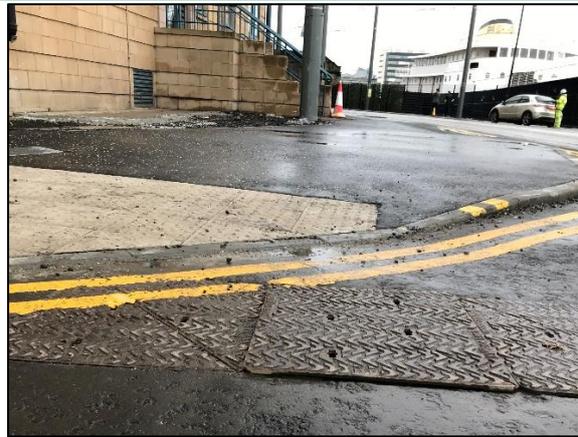
**Summary:** Risk of crossing pedestrians tripping on cover and sustaining personal injuries due to covers not being flush with surrounding carriageway.

A cover is provided within the extents of the crossing of Tower Place at its junction with Ocean Drive that is not flush with the surrounding carriageway. This is shown in the photograph above.

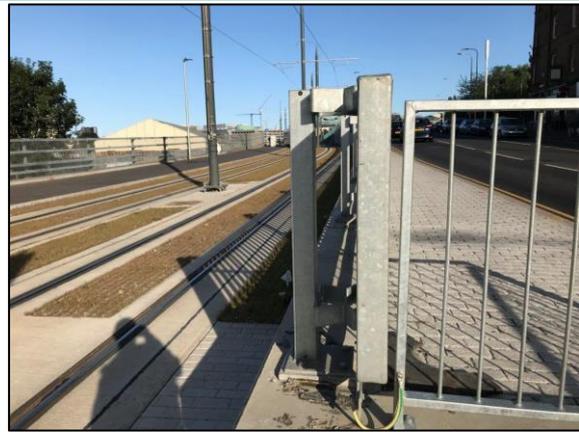
**Summary:** Risk of a pedestrian crossing in conflict with a westbound tram resulting in potential injury to pedestrian.

A pedestrian crossing point is provided across the tram tracks to the east of Newhaven tram stop. As shown in the photograph above, visibility on the south side of the crossing point is constrained to the right due to the level difference between the crossing point and guardrail to the right. This could result in there being inappropriate intervisibility between pedestrians waiting to cross and the drivers of approaching westbound trams. This could result in pedestrians crossing when it is not safe to do so and being struck and injured by approaching trams.

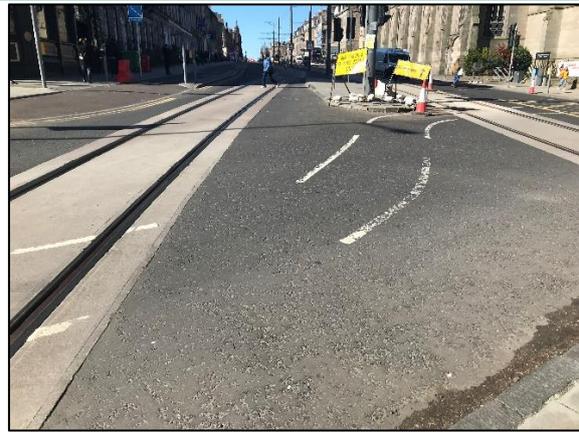
**Summary:** Risk of cyclists losing control whilst attempting to follow cycle lane due to geometry of lane, leading to them sustaining personal injuries.

It is unclear if the geometry of the cycle lane that links Picardy Gyratory and Broughton Street is suitable for use by all types of bicycles. If cyclists cannot follow the cycle lane and cross the cycle lane at a safe angle, there is a risk that cyclists could slip on the tram tracks and fall and sustain a personal injury.

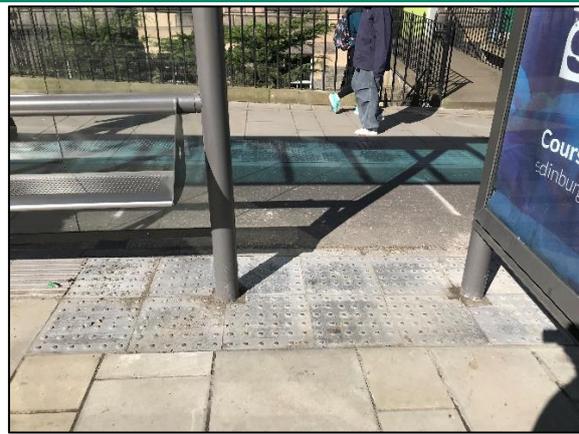
**Summary:** Risk of visually impaired pedestrians colliding with street furniture, due to position of bus stop with respect to uncontrolled crossing, resulting in them sustaining personal injuries.

As shown in the photograph above, a bus stop is provided within tactile paving associated with an uncontrolled crossing at this location. There is a risk that a visually impaired pedestrian crossing from west to east could collide with the bus shelter and sustain a personal injury, due to the shelter being located within the crossing extents.

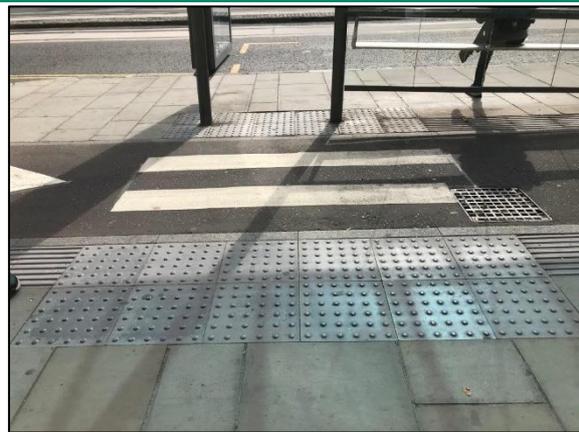
**Summary:** Risk of visually impaired pedestrians inadvertently entering cycleway due to absence of corduroy paving, resulting in them being struck and injured by cyclists.

There are several bus stops on Leith Walk where corduroy paving is not provided beyond the uncontrolled crossing across the cycleway. An example is shown in the figure above.

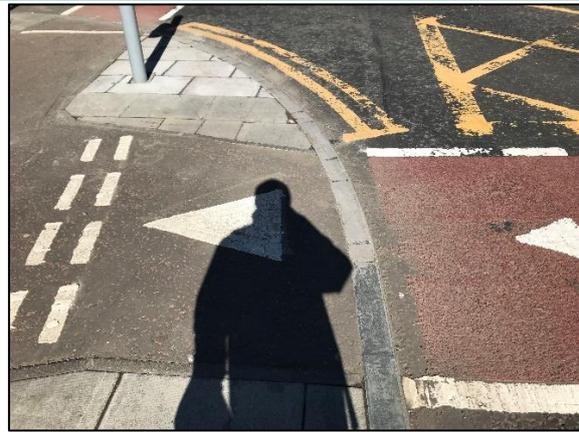
**Summary:** Risk of cyclists waiting on carriageway due to lack of storage space, leading to them being struck and injured by vehicles.

Limited storage space is provided for cyclists at several locations where on-road cyclists join the segregated cycleway. At these locations the on-road cyclists have to give way to cyclists already on the cycleway.

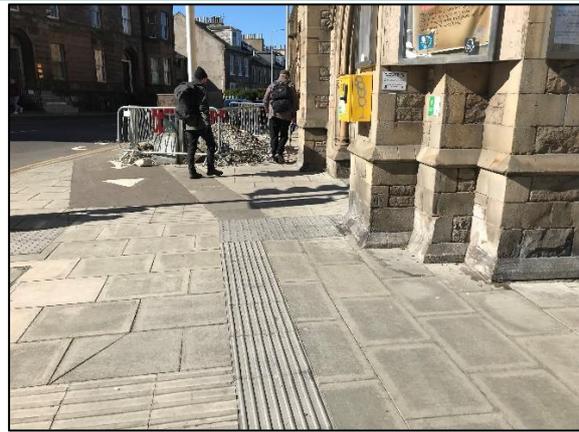
**Summary:** Risk of pedestrians stepping onto the cycleway to pass encumbered pedestrians or users using mobility aids due to restricted effective footway width, resulting in them being struck and injured by cyclists.

As shown in the photograph above, the effective footway width at Pilrig St. Paul's Church is restricted.

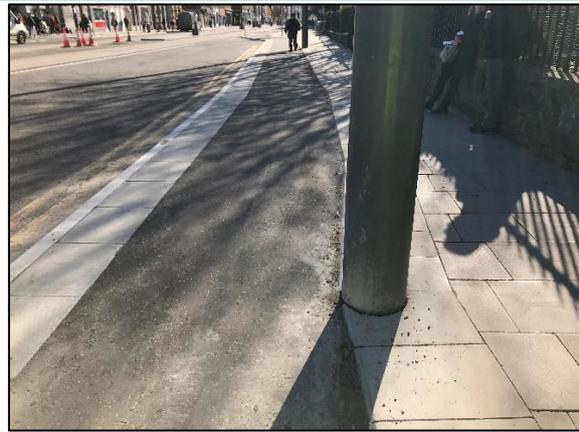
**Summary:** Risk of a cyclist colliding with the Overhead Line Electrification posts which are located on the edge of the new cycle lane, resulting in a cyclist falling and sustaining personal injury.

Near to the foot of the walk there are a number of Overhead Line Electrification (OLE) posts which are located immediately at the edge of the cycle lane. There is a risk that a northbound cyclist could clip the pole resulting in them falling and sustaining injury. This risk is heightened during the hours of darkness or periods of reduced visibility.

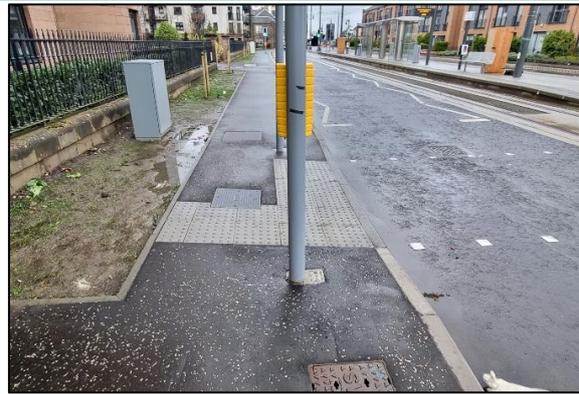
**Summary:** Risk of pedestrians stepping onto the carriageway to signal pole due to restricted effective footway width, resulting in them being struck and injured by vehicles.

As shown in the photograph above, the effective footway width on the south side of Ocean Drive is restricted by a traffic signal pole associated with the controlled crossing to the Port of Leith tram stop. The restricted effective footway width could lead to pedestrians stepping onto the carriageway to bypass the signal pole, which could result in them being struck and injured by vehicles whilst doing so.

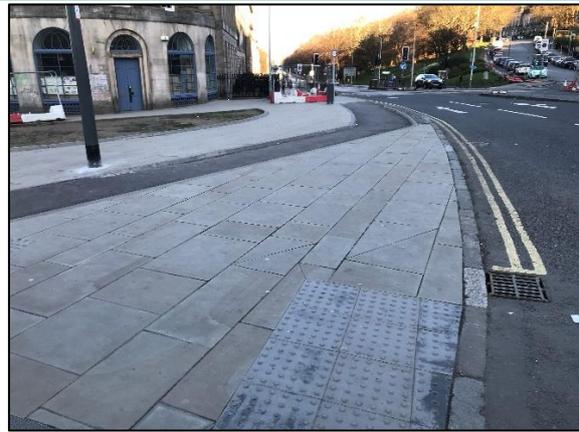
**Drawing(s):** ETYN-SEF-XXX-03-DR-D-1265

**Summary:** Risk of a pedestrian tripping on the segregated cycleway as a result of it being on the direct desire line between the crossing point and London Road.

Pedestrians crossing over London Road at the crossing point to head northwards are expected to continue northwards to cross the segregated cycleway at the mini zebra / courtesy crossing facility. However, pedestrians could turn right directly from the crossing point to head towards London Road and thereafter require crossing the segregated cycleway which cuts across the footway, and which is at a lower level. This could result in conflict between pedestrians and cyclists or pedestrians tripping on the kerbs on either side of the cycleway.

The desire line for London Road takes pedestrians over the cycleway at a point where there is no crossing facility. The Audit Team retain the above recommendation or would recommend that a further crossing point over the cycleway is provided on the desire line.

It is recommended that measures are provided to guide pedestrians to cross the cycle lane before heading towards London Road or that the area of footway is removed/landscaped to deter pedestrian use.
