# Tram Extension, Edinburgh

Ocean Terminal to York Place  
Road Safety Audit Stage 3

The City of Edinburgh Council

Project number: 60651312  
AECOM Reference: RSA/316/S3-A

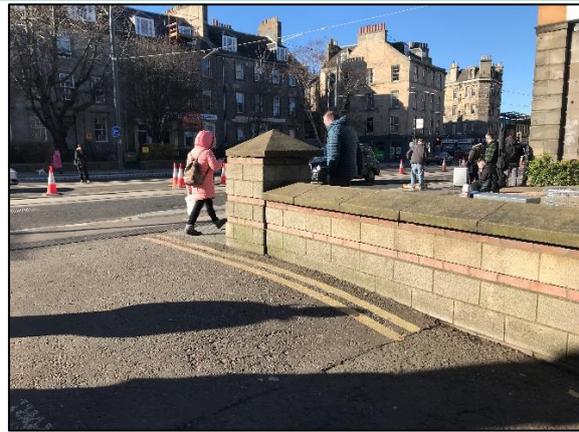
**Summary:** Risk of pedestrians stepping onto carriageway into path of oncoming vehicles due to intervisibility being constrained by column.

As shown in the photograph above, a wall with a column on the end is provided between Crown Place and the entry to Tesco. The Audit Team have concerns that the column could restrict intervisibility between pedestrians waiting to cross and the drivers / riders of approaching vehicles. This could result in a pedestrian, particularly a child or someone smaller in stature, stepping out from behind the column and into the path of an oncoming vehicle.

The Audit Team retain their belief that this is a problem and therefore retain the previous recommendation.

It is recommended that the height of the existing column is reduced to improve intervisibility.

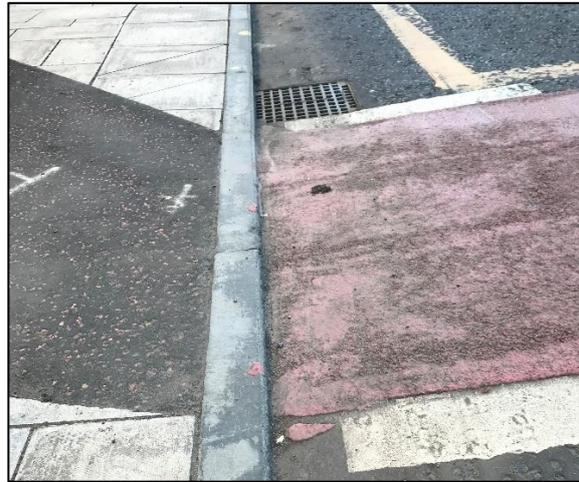
**Drawing(s):** ETYN-SEF-XXX-03-DR-D-1112

**Summary:** Risk of cyclists becoming unseated whilst attempting to transition between carriageway and cycleway due to kerb upstand.

As shown in the photograph above, the dropped kerb at the cycle transition at this location has an upstand greater than 6mm. There is a risk that a cyclist attempting to transition from the carriageway onto the cycleway could fall due to the upstand, resulting in them sustaining a personal injury.

NCR's/Defects have been raised and SFN will deal with them if they are out of the design tolerances.

The Audit Team note the designer's response, however, as this is still to be actioned, they retain the previous recommendation.

It is recommended that the dropped kerb is appropriate for cyclists to transition.

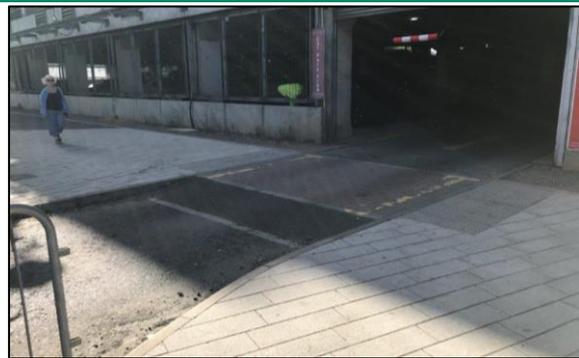
**Drawing(s):** ETYN-SEF-XXX-03-DR-D-1253

**Summary:** Risk of drivers / riders not observing raised table and losing control on ramp, resulting in vehicle striking a non-motorised user or piece of street furniture, due to absence of road markings on ramps.

A raised pedestrian crossing is provided across the vehicular access to the Ocean Terminal Red Car Park. As shown in the photograph above, no markings to Diag. 1062 (TSRGD 2016) are provided on the ramp on the approach to the crossing. As a result, the drivers / riders of approaching vehicles may not be aware of the raised crossing ahead, which could lead to them approaching the ramp at inappropriate speed, losing control, and striking a pedestrian or item of street furniture.

The Audit Team note the designer's response, however, as this is still to be actioned, they retain the previous recommendation.

It is recommended that appropriate markings to Diag. 1062 (TSRGD 2016) are provided on the ramp on the approach to the raised crossing.

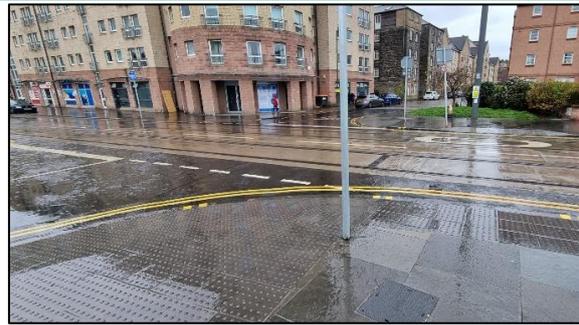
**Drawing(s):** ETYN-SEF-XXX-03-DR-D-1204

**Summary:** Risk of visually impaired pedestrians striking sign pole and sustaining a personal injury due to position of sign pole with respect to tactile paving.

As shown in the photograph above, a sign post is located to the rear of tactile paving on the east side of Ocean Way at its junction with Tower Place.

The Audit Team note the designer's response, however, as this is still to be actioned, they retain the previous recommendation. It should be noted that this is not a signal pole.

It is also noted that the crossing point at this corner could be misinterpreted by visually impaired pedestrians who could confuse the tactile paving on the radius and mistakenly cross over Ocean Way rather than Tower Place. In order to address this matter, it is recommended that the tactile paving layout is amended, which could both alleviate the issue of visually impaired pedestrians colliding with the signpost and the tactile paving being misinterpreted.

It is recommended that the sign post is relocated to minimise the risk of visually impaired pedestrians colliding with it.

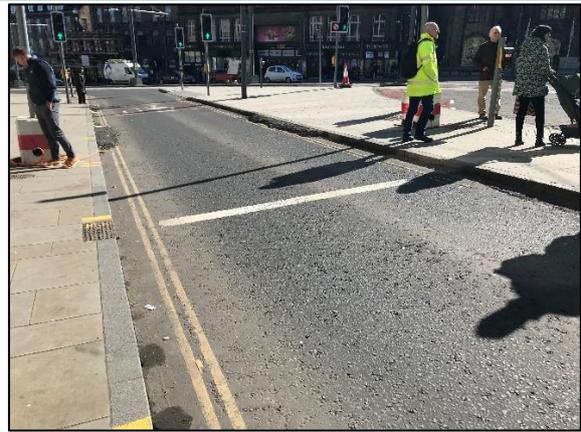
**Drawing(s):** ETYN-SEF-XXX-03-DR-D-1265

**Summary:** Risk of rear end shunts due to sudden braking at random stop line on York Place.

As shown in the photograph above, a random stop line is provided on York Place at its junction with Leith Walk. There is a risk that a driver / rider may be confused by the position of this stop line and brake suddenly. This could result in a rear-end shunt collision.

The Audit Team note the designer's response, however, as this is still to be actioned, they retain the previous recommendation.

It is recommended that the stop line is removed.

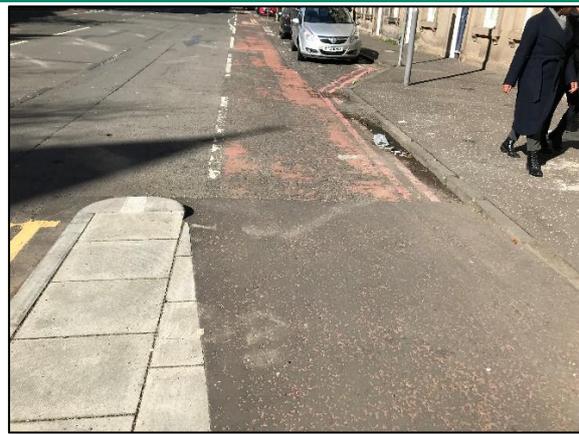
**Drawing(s):** ETYN-SEF-XXX-03-DR-D-1263

**Summary:** Risk of cyclists being unaware of presence of ramp, leading to them becoming unseated or losing control.

No road marking to Diag. 1062 (TSRGD 2016) is provided in the cycle transition on McDonald Road eastbound. There is a risk that this could lead to cyclists being unaware of the presence of the ramp and could lead to them being unseated or losing control when hitting the bottom of the ramp.

The Audit Team note the designer's response, however, as this is still to be actioned, they retain the previous recommendation.

It is recommended that an appropriate road marking to Diag. 1062 (TSRGD 2016) is provided at this location.

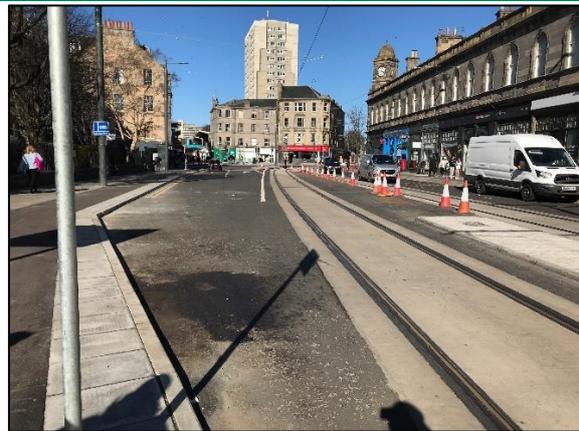
**Drawing(s):** ETYN-SEF-XXX-03-DR-D-1260;  
ETYN-SEF-XXX-03-DR-D-1262;  
ETYN-SEF-XXX-03-DR-D-1264

**Summary:** Risk of vehicles undertaking sudden manoeuvres due to being unaware of start of tram lane, resulting in side swipe or rear end shunt type collisions.

There are several locations on Leith Walk where the offside lane becomes tram only and general traffic in the offside lane has to merge back into the nearside lane. At each of these locations, no tapered road marking is provided to guide vehicles back into the nearside lane. Such markings have been used elsewhere on the tram network within Edinburgh, typically eastbound at Shandwick Place prior to the tram stop.

As this has not been actioned, the Audit Team retain the previous recommendation.

It is recommended that tapered tram lane road markings are provided at these locations.

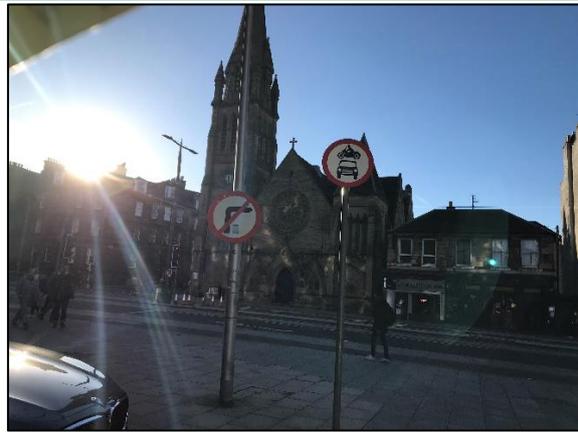
**Drawing(s):** ETYN-SEF-XXX-03-DR-D-1212

**Summary:** Risk of vehicles proceeding across through prohibition of motor traffic restriction, leading to them striking and injuring non-motorised users, due to conflicting signage.

A prohibition of motorised traffic is in place at the junction of Iona Street and Leith Walk. As shown in the photograph above, in addition to the sign to Diag. 619 (TSRGD 2016) showing the prohibition of motor vehicles, a no right turn sign (Diag. 612, TSRGD 2016) is also provided. This paints a confusing message for the drivers / riders of approaching vehicles. There is a risk that this could lead drivers / riders to believe that they can turn left onto Leith Walk from Iona Street, which could lead to them striking and injuring non-motorised users whilst doing so.

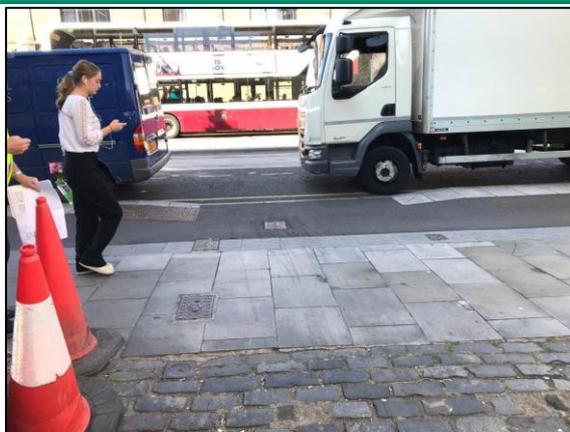
**Summary:** Risk of vehicles driving on footway or cycleway and striking and injuring non-motorised users or emerging from access and colliding with southbound vehicles on Leith Walk due to position of parked vehicles.

As shown in the photograph above, no gap is provided in the parking bay on the east side of Leith Walk, south of Manderston Street, to enable vehicles to transition between Leith Walk and Manderston Street.

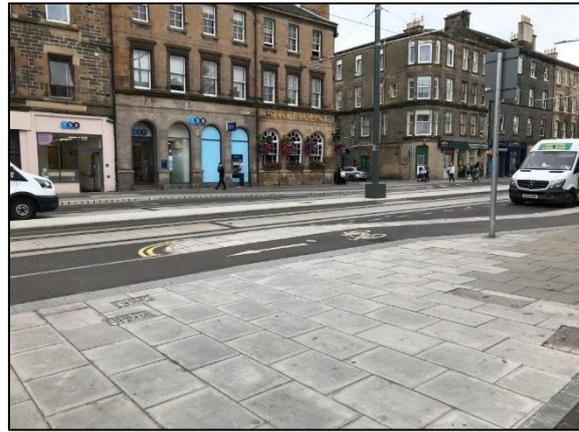
**Summary:** Risk of collisions between vehicles and other road users due to visibility being obscured at junction by parked vehicles.

As shown in the photograph above, a parking bay is located to the south of Casselbank Street. The Audit Team have concerns that a vehicle parked in the parking bay could restrict intervisibility between crossing non-motorised users and vehicles turning into Casselbank Street.

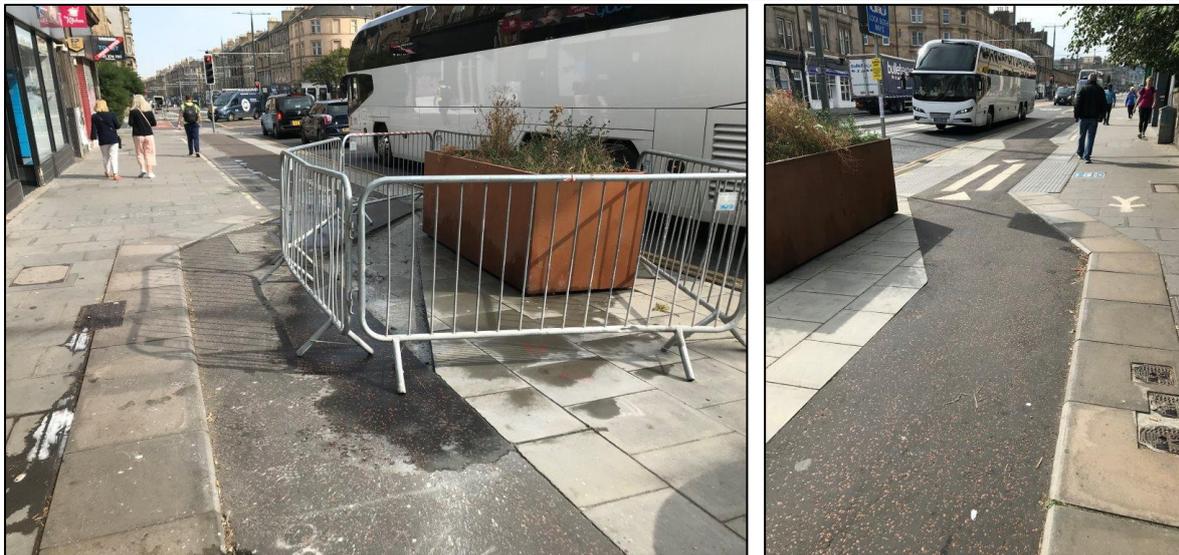
**Summary:** Risk of cyclists striking planter, causing them to fall from their bicycle and sustain a personal injury.

As shown in the photographs above, two planters are provided adjacent to the cycleway on the northbound approach to Pilrig Street. A limited offset is provided between the cycleway and the planters.

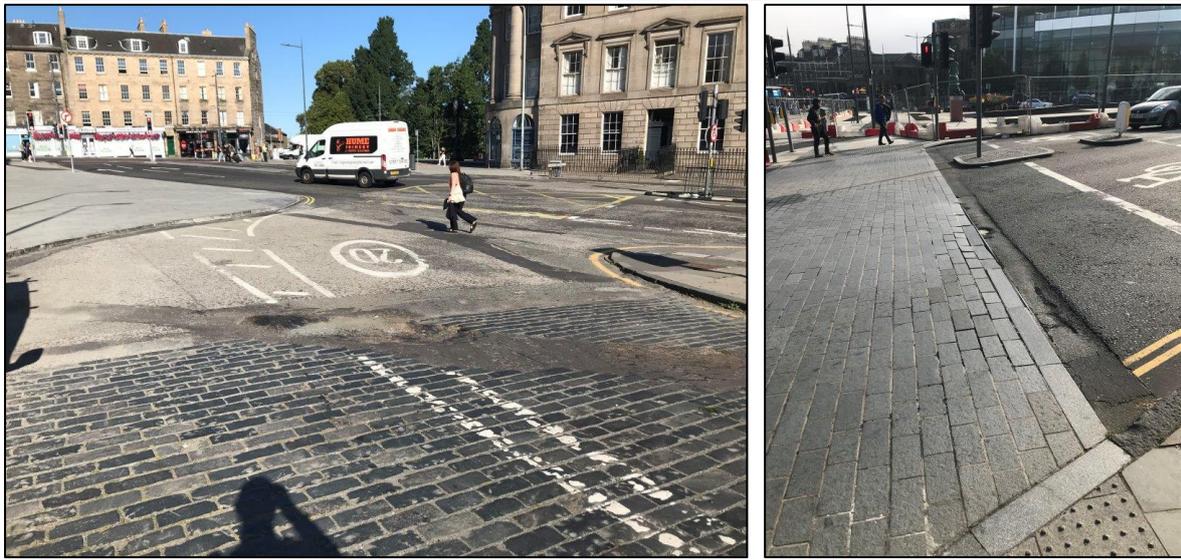
**Summary:** Risk of bicycles or powered two wheelers losing control on uneven carriageway surface, resulting in riders becoming unseated and sustaining personal injuries.

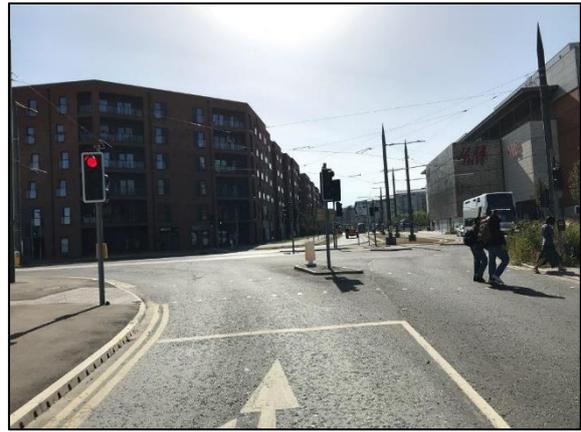
**Problem: 4.3.3**

**Summary:** Risk of vehicles proceeding across the stop line when not safe to do so and striking and injuring crossing pedestrians, due to orientation of secondary signal head.

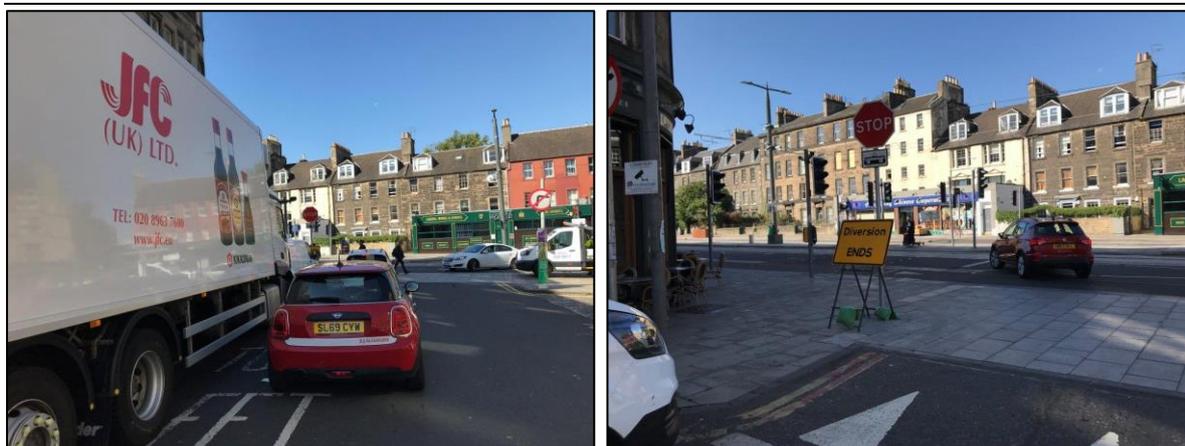
**Summary:** Risk of vehicles turning onto Leith Walk from Dalmeny Street and striking and injuring crossing pedestrians due to position of crossing, visibility of signal heads, and constrained visibility on approach.

A layby is provided on the south side of Dalmeny Street at its junction with Leith Walk. As shown in the photograph above, a large vehicle was parked in this loading bay, which obstructed forward visibility to the crossing downstream of Dalmeny Street.

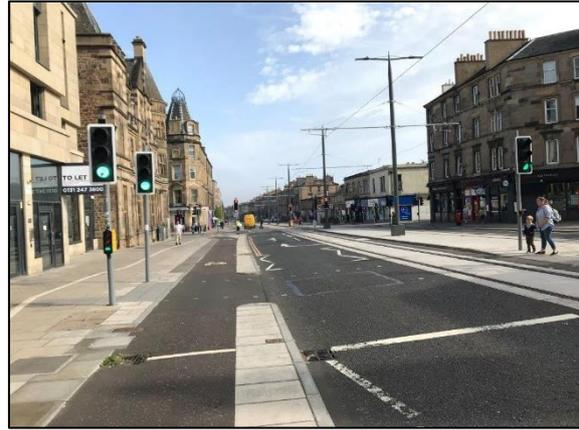
**Summary:** Risk of vehicles proceeding across stop line when not safe to do so, and striking and injuring crossing pedestrians whilst doing so, due to "see-through" to traffic signals downstream.

As shown in the photograph above, it is possible to see the traffic signals at the junction of Leith Walk, McDonald Road, and Brunswick Road from the upstream crossing.

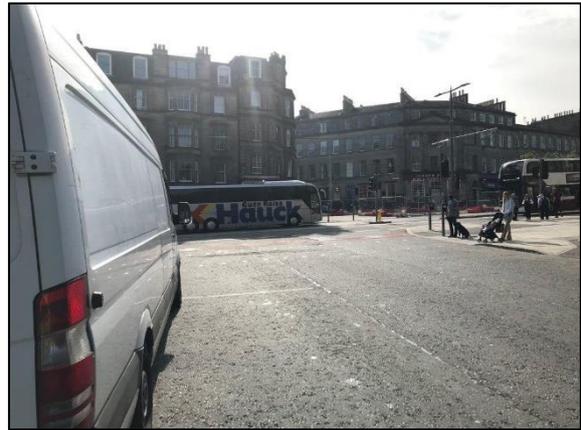
**Summary:** Risk of vehicles proceeding across stop line when not safe to do so and colliding with crossing non-motorised users or other vehicles, due to visibility to signal head being obscured by parked vehicles.

As shown in the photograph above, a van was parked on the north side of Annandale Street at its junction with Leith Walk. There are no kerbside restrictions at this location and the van blocked the entry to the cycleway and obscured visibility to the primary signal head.

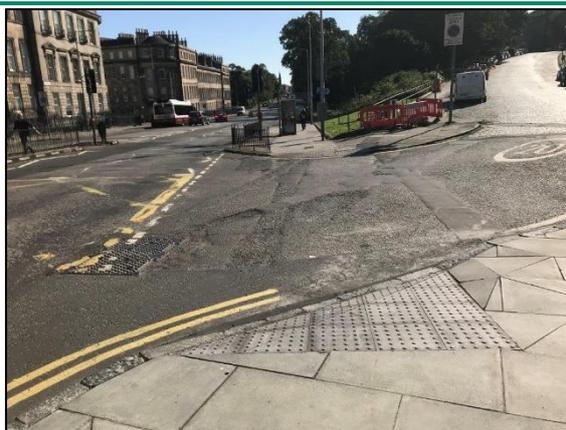
**Summary:** Risk of visually impaired pedestrians inadvertently stepping onto the carriageway and being struck and injured by passing vehicles due to tactile paving being insufficiently deep.

Tactile paving has been provided on Melrose Drive at the cruise terminal egress and on Blenheim Place at its junction with London Road. The tactile paving that has been provided is insufficiently deep and could be missed by a visually impaired pedestrian crossing at these locations.

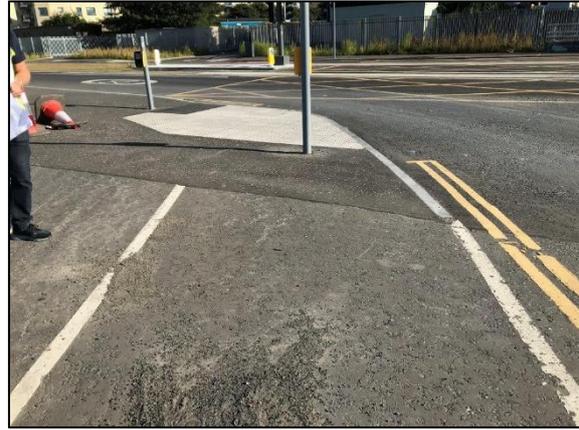
**Summary:** Risk of visually impaired pedestrians becoming stuck on the carriageway and being struck and injured by vehicles due to lack of delineation between carriageway and shared use footway.

At the access to ADM milling and Aggregate Industries on Melrose Drive, the footway ends to the rear of Melrose Drive and transitions into an area that is flush to the carriageway and separated from the carriageway by white lining.

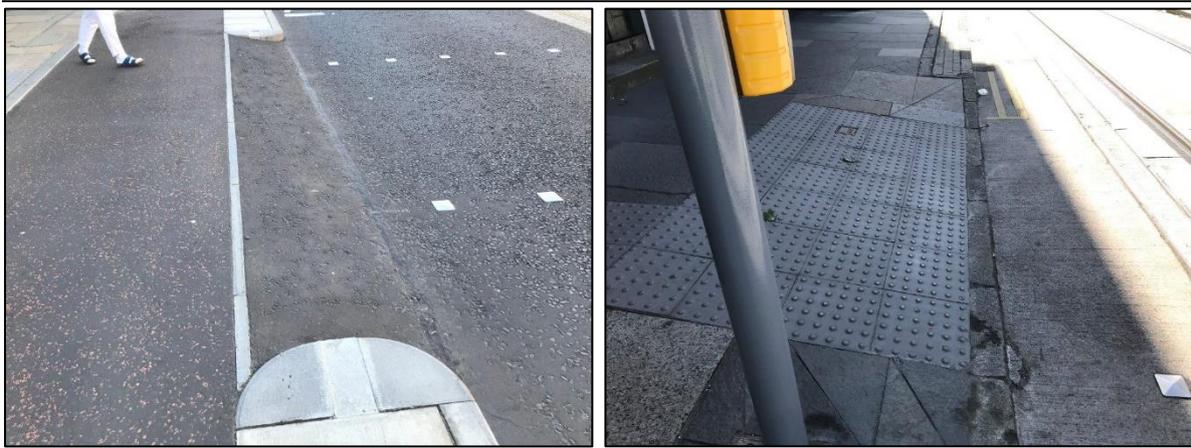
**Summary:** Risk of users in mobility chairs overturning and sustaining personal injuries due to gradients of crossing points.

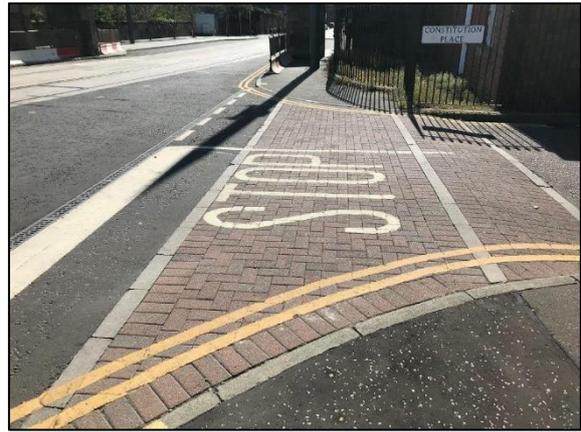
**Summary:** Risk of visually impaired pedestrians inadvertently stepping onto the carriageway and being struck and injured by passing vehicles due to absence of tactile paving.

As shown in the photograph above, no tactile paving is provided on Constitution Place at its junction with Ocean Way. This could lead to a visually impaired pedestrian being unaware that they are stepping onto the carriageway, which could result in them being struck and injured by an approaching / turning vehicle.

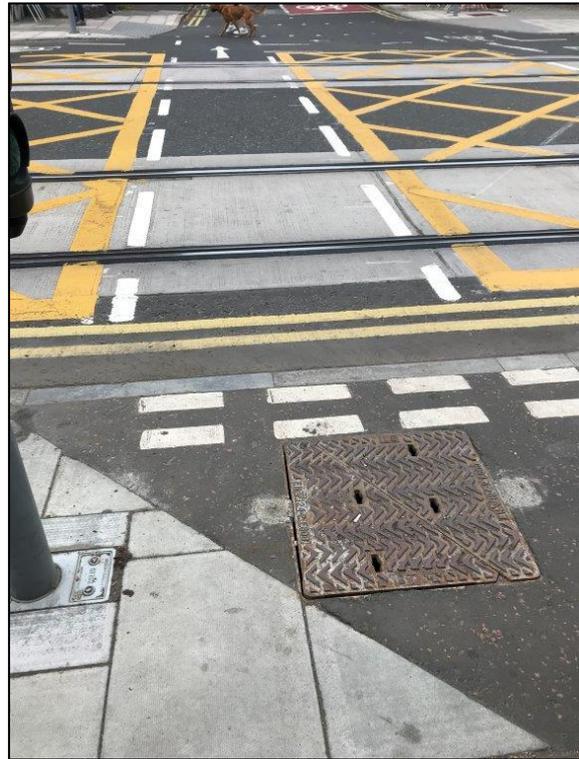
**Summary:** Risk of cyclists crossing when not safe to do so and being struck and injured by vehicles due to lack of clarity regarding the requirement to stop.

As shown in the photograph above, a give way line is provided within the cycle crossing from the west side of Leith Walk at Manderston Street. This could lead a cyclist to believe that they do not need to obey the traffic signals and could cross and strike a crossing pedestrian or be struck by a vehicle on Leith Walk.

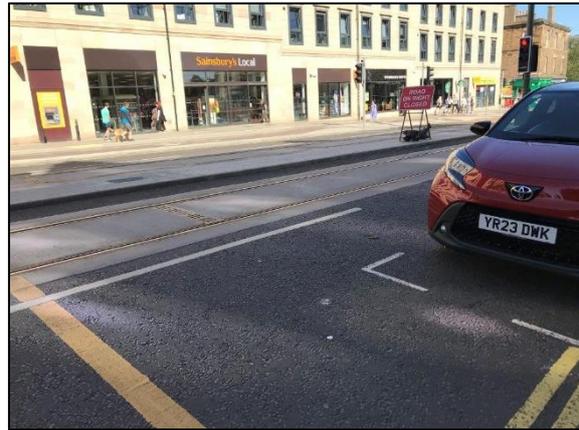
**Summary:** Risk of crossing pedestrians stepping into the path of oncoming vehicles due to intervisibility at crossing being obscured by parked vehicles.

Parking bays are provided immediately upstream of two uncontrolled crossings across Leith Walk: on the west side, south of Pilrig Street, and on the east side, south of Albert Street.

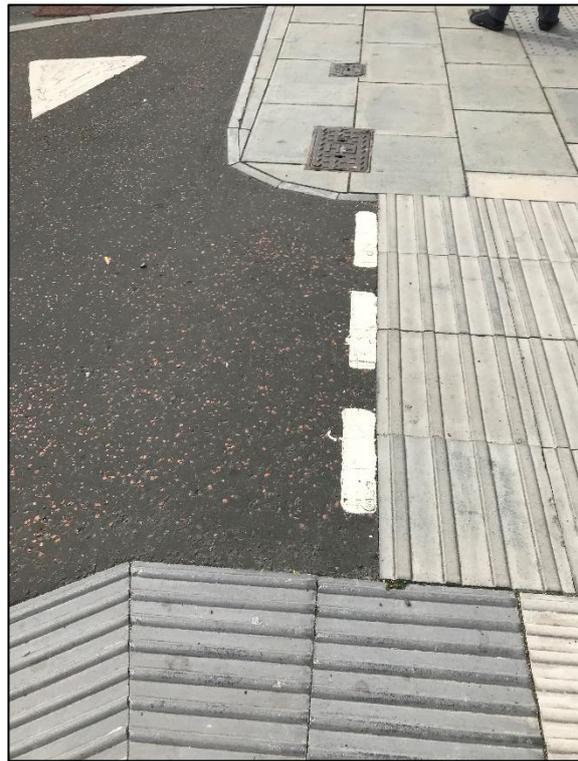
**Summary:** Risk of cyclists colliding due to unclear priority.

As shown in the photograph above, limited road markings are provided to indicate which cycle movement has priority at this location. It is assumed that the eastbound movement on Pilrig Street is to give way to the northbound movement on Leith Walk, but only one row of markings to Diag. 1003 (TSRGD, 2016) are provided, and these could be missed by cyclists due to being immediately adjacent to the ladder paving.

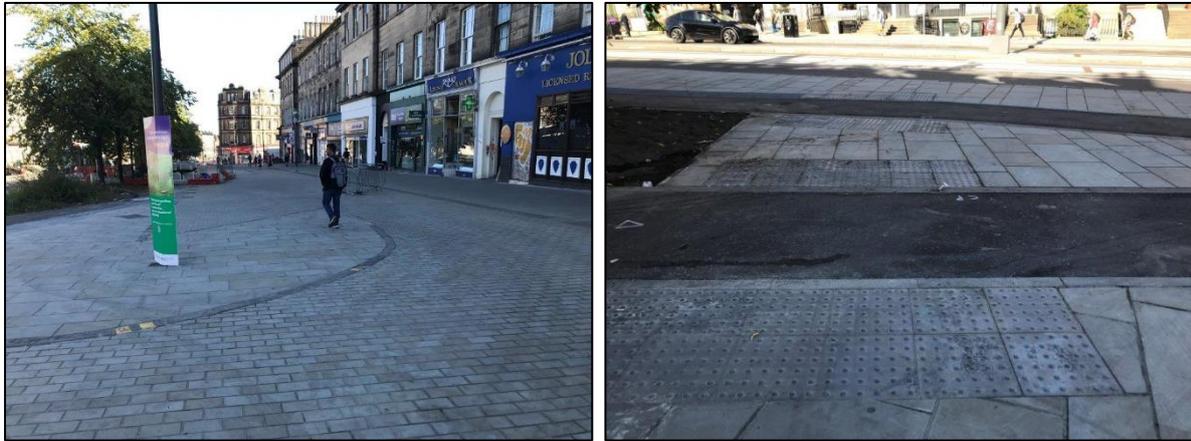
**Summary:** Risk of pedestrians being struck and injured by cyclists or motorised vehicles due to lack of delineation between carriageway, footway, and cycleway.

The footway and carriageway at Elm Row are all flush, and, beyond different surfacing, no measures are provided to delineate them. The Audit Team have concerns that this could lead to confusion for pedestrians, who could inadvertently enter the carriageway and be struck and injured by motorised vehicles.

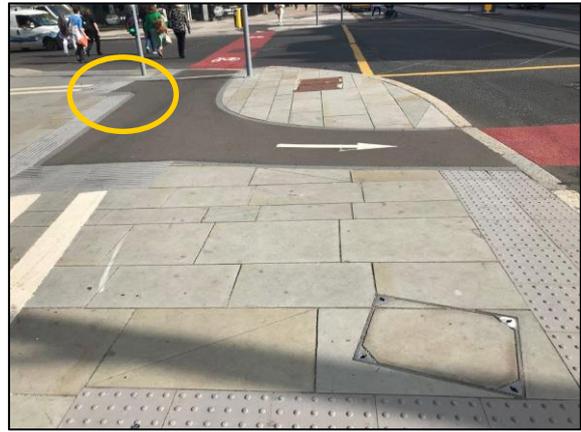
**Summary:** Risk of cyclists cutting corner of cycleway and striking and injuring pedestrians whilst doing so.

A very tight radius is provided in the cycleway on the west side of Leith Walk at the junction with Annandale Street. The radius is between the southbound cycleway and the cycleway on the south side of Annandale Street, and is shown in the photograph above circled in yellow.

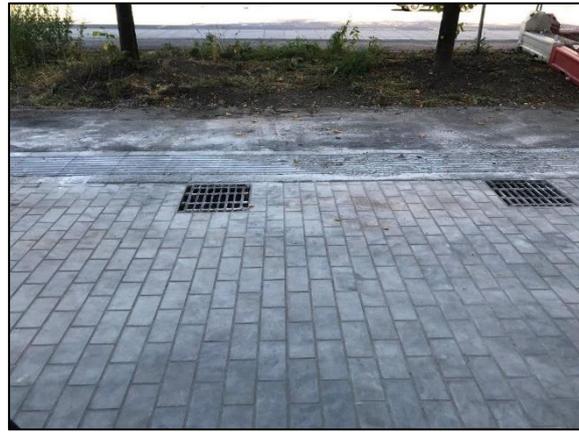
**Summary:** Risk of parked or loading vehicles overhanging or unloading items into cycleway, leading to cyclists striking them and sustaining personal injuries.

At the southbound cycleway on Elm Row, no measures are provided between the parking area and the cycleway to prevent vehicles from overhanging the cycleway or loading within the cycleway. There is a risk that this could lead to vehicles striking cyclists when reversing into a space, cyclists striking vehicles overhanging the cycleway, or cyclists striking objects or pedestrians whilst materials are being loaded or unloaded.

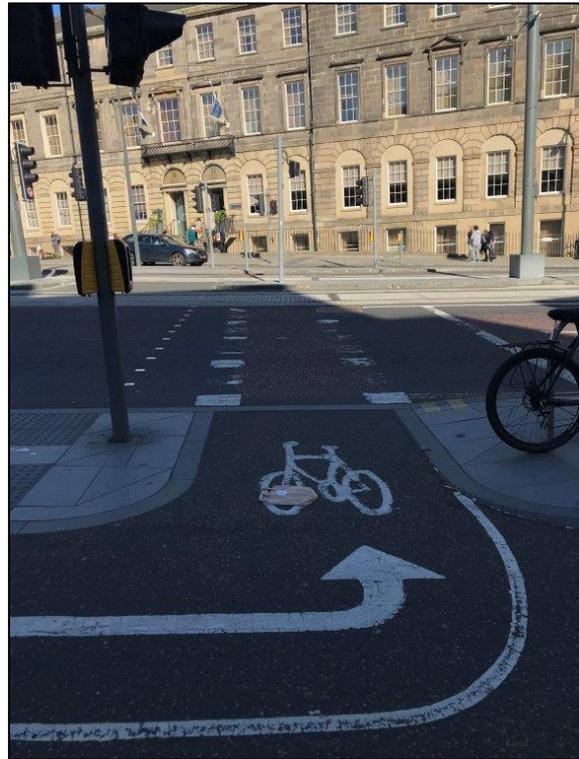
**Summary:** Risk of cyclists attempting to cross, finding there is no facility opposite, and continuing into pedestrian crossing or footway and striking and injuring a pedestrian whilst doing so.

During the site investigation it was noted that a cycle crossing across Leith Walk, north-east of Picardy Place gyratory, did not link to infrastructure on the west side of Leith Walk. There is a risk that a cyclist could attempt to cross at this location, find there is no facility opposite, and continue into the pedestrian crossing and into conflict with crossing pedestrians or mounting the footway and striking and injuring a pedestrian whilst doing so.

It is recommended that the cycle crossing is removed.

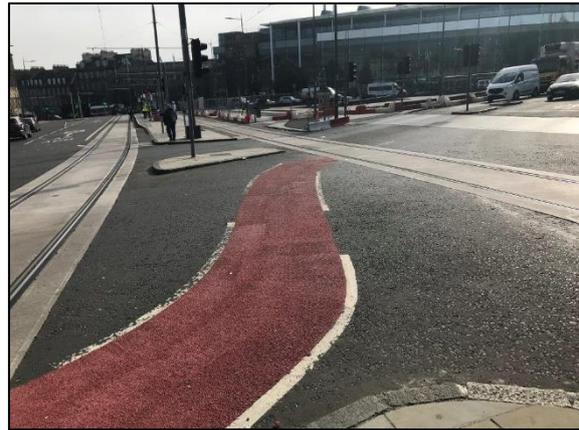
**Summary:** Risk of vehicle striking and injuring a cyclist due to alignment of advisory cycle lane.

On the west side of Picardy Place gyratory, the advisory cycle lane has an S-shape. This takes cyclists from the offside of the ahead lane to the nearside of Broughton Street.

Notwithstanding the recommendation in 3.3.33 above; it is recommended that the arrangement is appropriately amended to reduce the risk of a cyclist being struck by a following vehicle.

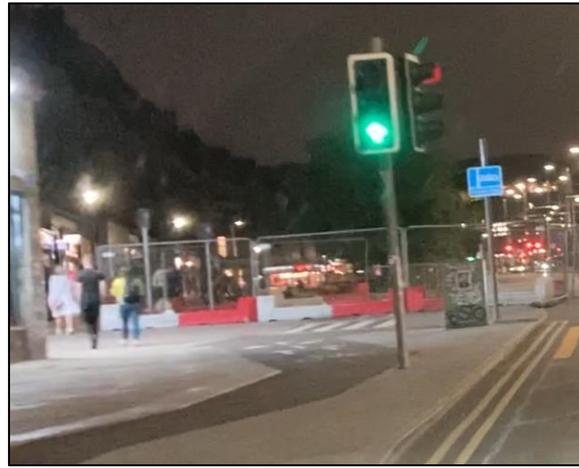
**Summary:** Risk of cyclists striking and injuring pedestrians due to route not being continuous.

Secondary risk of cyclists merging onto carriageway when not safe to do so and being struck and injured by vehicles, due to route not being continuous.

The new section of cycleway on Elm Row is not currently open to the public. A cyclist travelling southbound would either have to transition onto the carriageway or continue across the footway on Elm Row. If they were to merge onto the carriageway and into traffic, there is a risk that they could be struck and injured by a passing vehicle whilst doing so. If they were to cut across a footway, there is a risk that they could strike and injure a pedestrian whilst doing so.

It is recommended that suitable infrastructure is provided to enable cyclists to continue southbound whilst the section of cycleway on Elm Row is closed.

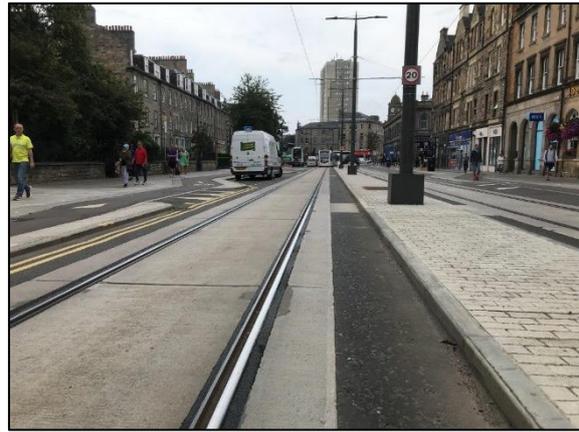
**Summary:** Risk of vehicles undertaking late lane changes to avoid entering tram lane resulting in side-swipe collisions, due to start of tram lane sign being obscured by parked vehicles.

As shown in the photograph above, the start of tram lane sign on Leith Walk northbound can be obscured by vehicles parked in the layby. This could lead to drivers / riders being unaware of the start of the tram lane, resulting in them undertaking late lane changes and side-swipe collisions occurring.

It is recommended that appropriate forward visibility is provided to the start of tram lane sign.

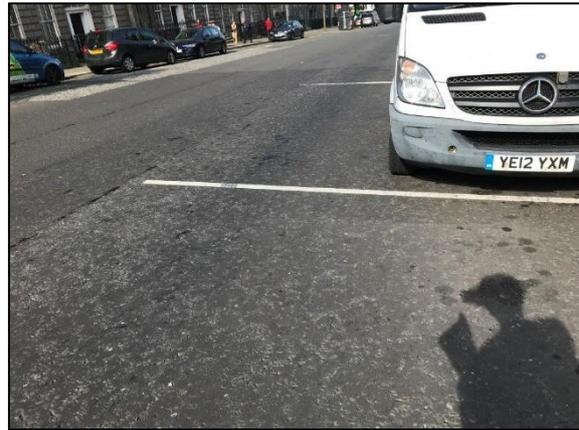
**Summary:** Risk of vehicles braking sharply due to provision of road markings, resulting in rear-end shunt collisions.

As shown in the photograph above, there are series of random transverse road markings on Annandale Street on the approach to Leith Walk. There is a risk that a driver / rider could mistakenly believe that one of the transverse road markings upstream of the stop line is the stop line, which could lead to them braking sharply and could result in rear-end shunt collisions.

It is recommended that the transverse lines on the approach to the signalised junction are removed.

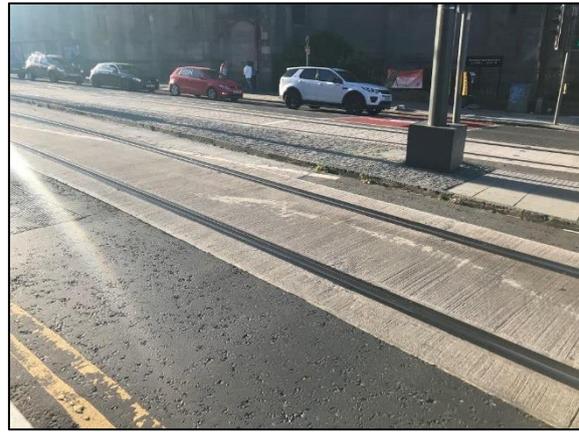
**Summary:** Risk of vehicles making sudden manoeuvres resulting in side-swipe collisions, due to worn road markings.

As shown in the photograph above, the deflection arrow at this location was very worn. There is a risk that the driver / rider of an approaching vehicle could fail to observe the deflection arrow, due to its condition, and make a sudden manoeuvre upon realising that they are about to enter the tram only lane. This could result in side-swipe collisions.

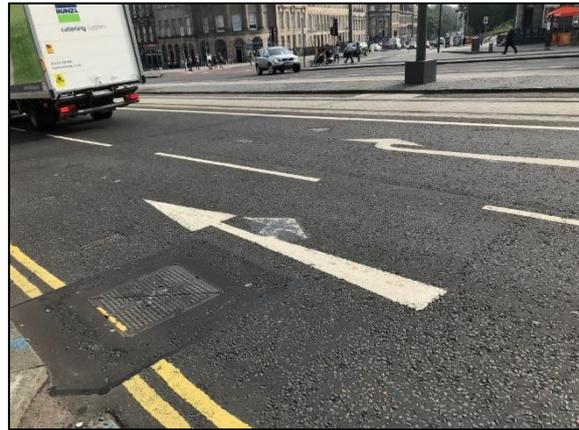
**Summary:** Risk of vehicles attempting to turn right from nearside lane on Leith Walk, resulting in side-swipe collisions, due to road markings not having been ineffectively removed.

During the site investigation it was noted that it appeared that the right turn arrows in the nearside lane had been attempted to be removed at this location. However, they were still visible, as shown in the photograph above.

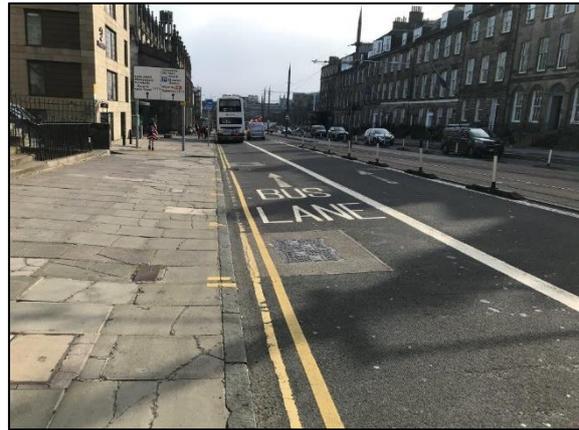
**Summary:** Risk of side swipe collisions due to vehicles merging due to the presence of bus lane.

Secondary risk of vehicles braking sharply when trying to merge, leading to rear-end shunt collisions, due to the presence of bus lane.

A bus lane is provided in the nearside lane on York Place eastbound. Whilst the bus lane terminates upstream of the Picardy Place gyratory, limited storage is provided. At the junction, the nearside lane is for northbound and eastbound traffic, while the offside lane is for southbound traffic.

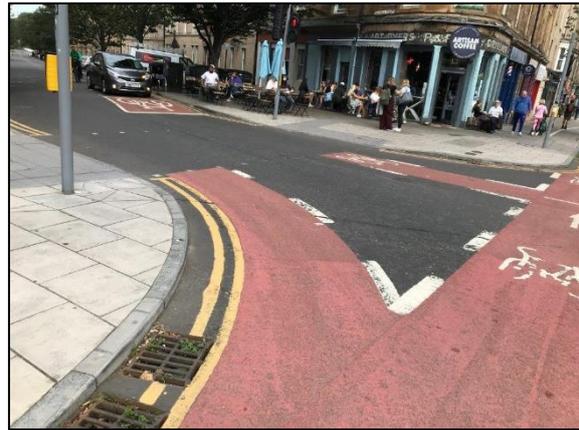
**Summary:** Risk of head-on collisions or side swipe collisions between vehicles entering Balfour Street and exiting vehicles due to the lane configuration and cycle lane markings.

As can be seen in the above photograph, the cycle lane from Leith Walk extends for a short distance into Balfour Street. This cycle lane marking effectively pushes general vehicles intending to turn left into Balfour Street out towards the centre of the road. This arrangement places vehicles into direct conflict with any vehicles exiting the side road or waiting at the stop line. This could result in a head-on or side swipe collision.
